## Reconnaissance report and preliminary ground motion simulation of the 12 May 2008 Wenchuan earthquake

Louise Wedderkopp Bjerrum · Kuvvet Atakan ·  
Mathilde Böttger Sørensen

**Keywords** Damage distribution · Field reconnaissance · Ground motion simulation · Wenchuan earthquake

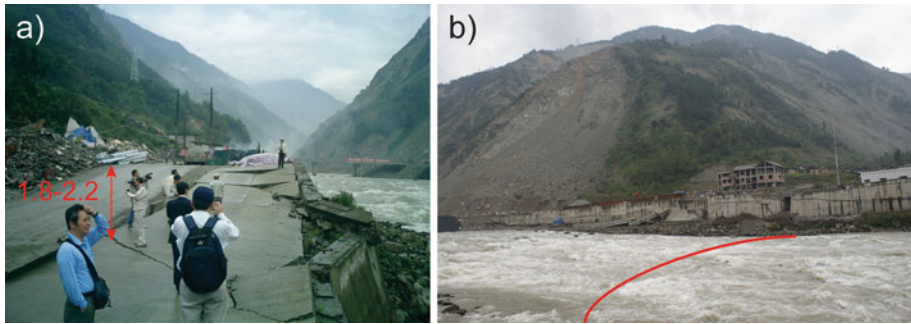
The fault scarp in Yingxiu is located at (31.065°N; 103.490°E). The displacement observed was pure thrust with a vertical displacement of 1.8–2.2 m (Fig. 3). The fault has

**Fig. 3** Fault scarp, Yingxiu. **a** Surface rupture crossing and deforming the main road, which was flat prior to the earthquake. **b** Fault scarp continuing across the river. The approximate location of the surface rupture is shown by a *red stippled line*. A landslide scarp is visible on the hill side in the background

a strike of  $240\text{--}250^\circ$  and a dip of  $30\text{--}50^\circ$  at this location, crossing and deforming the main road (Fig. 3a). Eyewitnesses confirmed that the earthquake created a 2 m vertical scarp on the river bed, resulting in a small waterfall, which had gradually eroded away before our visit. In the background of Fig. 3b scarps after landslides are visible.

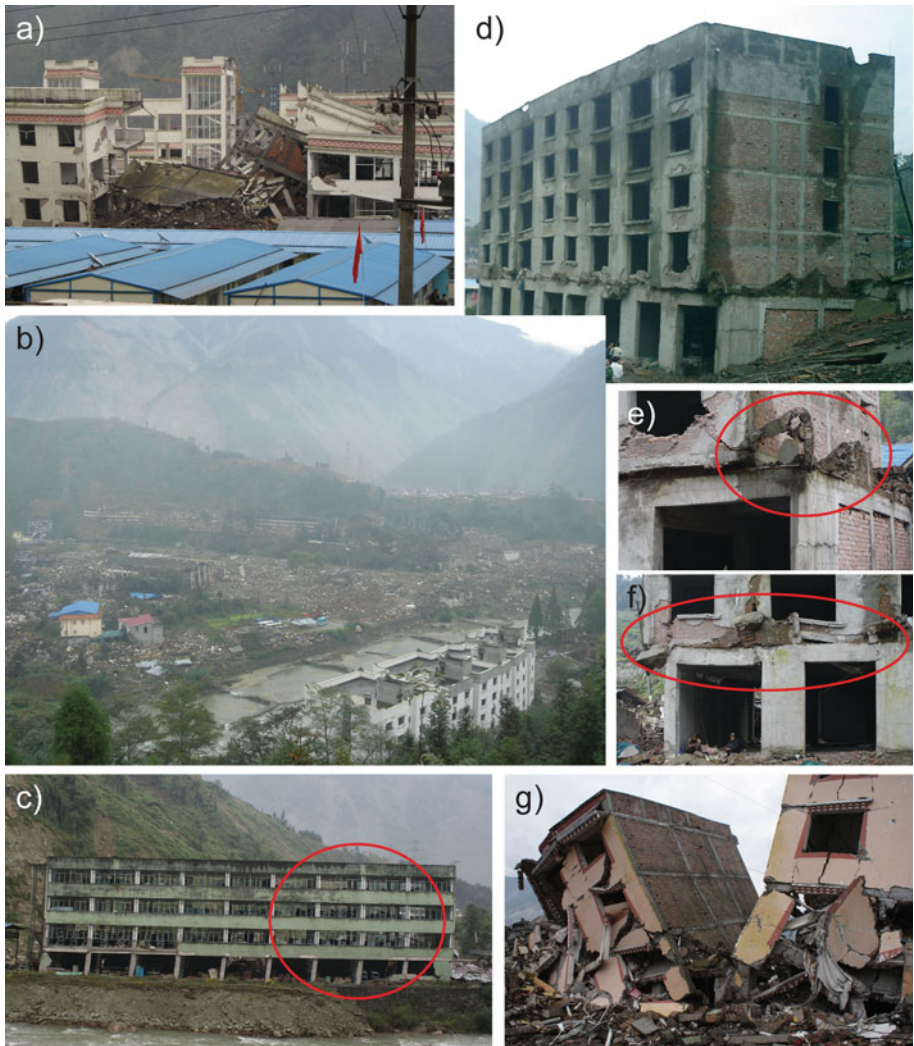
In Fig. 4, various types of building damage in Yingxiu are shown. Approximately 80% of the buildings in central Yingxiu collapsed during the earthquake, and it is planned that parts of the destroyed city will be preserved as a memorial museum. The massive destruction in Yingxiu is consistent with the short distance to the rupture initiation point from city and the thrust mechanism of the displacement. The high level of ground shaking experienced in the area was a consequence of proximity to the asperity with the largest displacement across the fault plane, estimated by waveform inversion (e.g. Ji and Hayes 2008; Nishimura and Yagi 2008; Zhao et al. 2010), as well as large displacements at the surface and is expressed through the damage to buildings and infrastructure (Fig. 4b). The buildings in the area were predominantly of reinforced concrete (RC) with brick infill (see Fig. 4a, the Xuankou Middle School, built in 2005 as an example). The damage observed varies from non-structural damage to total collapse of buildings. For further information on the damaged school buildings, see Zhao et al. (2009). Strong ground shaking is verified in Fig. 4c, where a factory building is clearly tilted and has been close to a collapse of the ground floor. The structures still standing had suffered heavy structural damage, ranging from soft storey collapse due to failure of columns (Fig. 4d–f) to partial collapse (Fig. 4g).

**Fig. 4** Building damage at Yingxiu Town of Wenchuan County. **a** Xuankou Middle School, shelter buildings are visible in the foreground. **b** Overview of Yingxiu where ca. 80% of the city's buildings collapsed during the earthquake. **c** Factory building with clearly tilted columns. **d–f** Six-story RC-brick infill building which suffered a single story collapse of the second floor. **g** Partial collapse of residential buildings

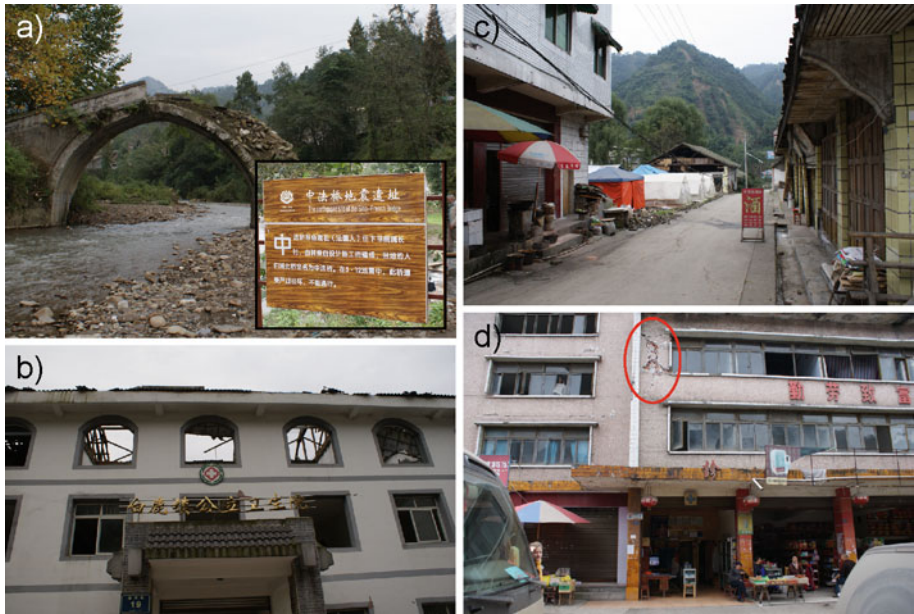
The maximum observed ground motion in the area was  $633 \text{ cm/s}^2$ . This was recorded on the vertical component at Bijiao station, approximately 70 km from the epicenter (Li et al. 2008a). In Bailu, there was widespread damage to buildings and infrastructure. The historical masonry bridge (Zhongfa) connecting the Bailu Middle School to the city (Fig. 6a) collapsed during the earthquake. The hospital building of Bailu was damaged and the roof collapsed (Fig. 6b). The remaining buildings, which apparently did not suffer any structural damage, were still in use, although there were clear signs of cracks on the brick-walls (Fig. 6c,d). The

**Fig. 6** Damage to structures in the city of Bailu. **a** Zhongfa Bridge crossing the river in Bailu. **b** City hospital, which suffered from roof collapse. **c–d** Main street of Bailu, where large cracks are visible in the house walls. Temporary shelters and tents are visible in the background of **c**

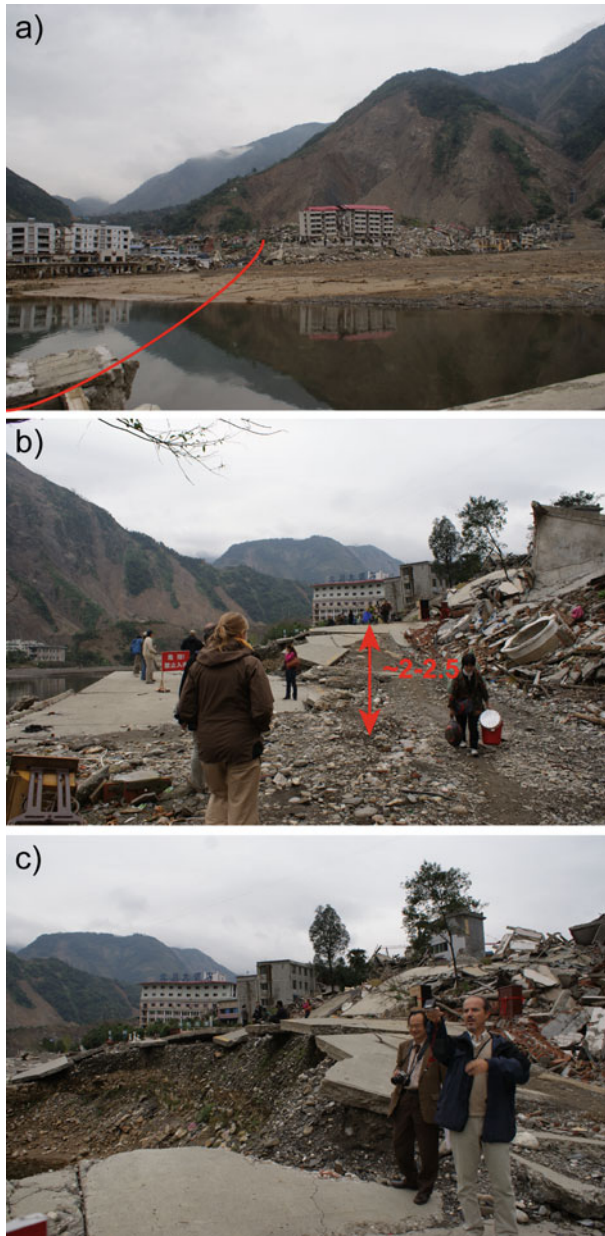
The ground motions in Beichuan exceeded  $350 \text{ cm/s}^2$  during the earthquake, with the largest ground motions on the vertical component (Li et al. 2008b). The fault scarp runs through the city in the area between the old and the new part of town ( $31.829^\circ\text{N}$ ;  $104.457^\circ\text{E}$ , Fig. 9). The strike of the fault is found to be  $230\text{--}240^\circ$ , and the vertical displacement was 2–2.5 m. Scarps due to the extensive landslides covered the mountain sides, and part of the

**Fig. 9** Fault scarp in Beichuan, crossing the river with a 2.5 m uplift. **a** View towards SW, the old part of Beichuan with alluvial material in the foreground, the *red line* marks the continuation of the fault across the valley. **b** Surface rupture in Beichuan. The picture is taken towards the new part of town to the NE, at the same location as (a). Vertical uplift of 2–2.5 m was measured in Beichuan, as indicated with the *red arrow*. **c** Close-up of the fault scarp, where deformed concrete road blocks and rubble from collapsed buildings are visible

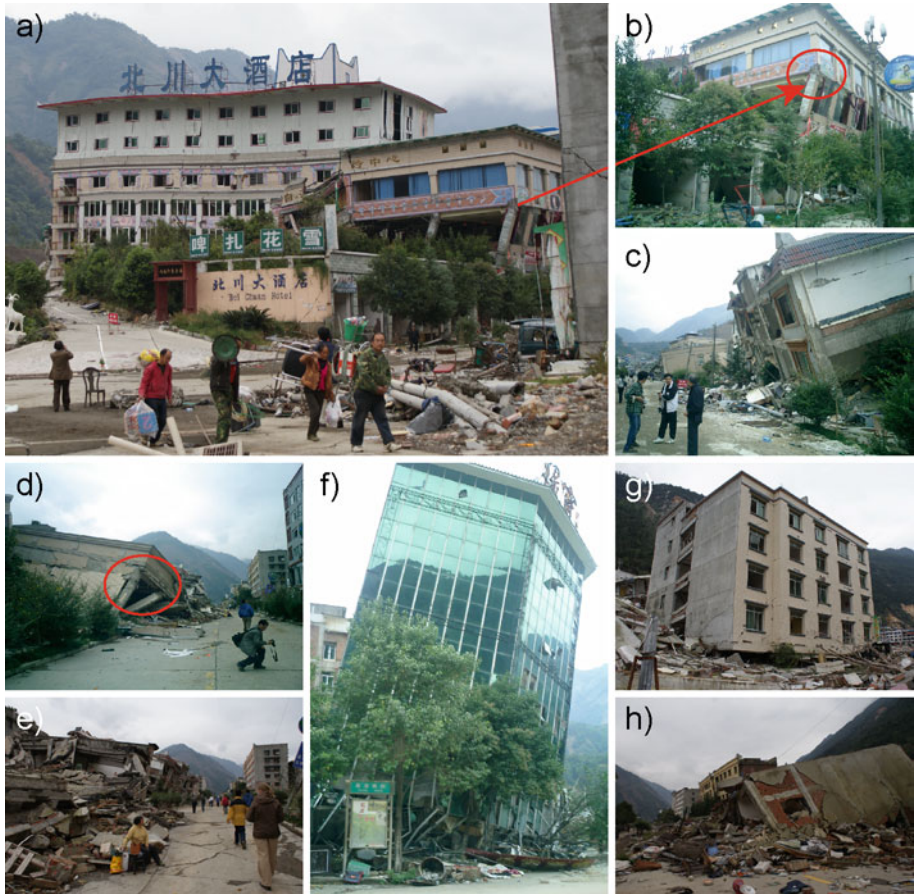
Various types of building damage are observed in Beichuan, ranging from non-structural damage to total or partial collapse (Fig. 10). The Bei Chuan Hotel sustained the strong ground shaking and did not collapse. However, failures at the column beam joints are visible and the hotel is no longer habitable (Fig. 10a, b). In the main street of the new part of Beichuan (Fig. 10c–e), weak structures, with partly open-ground storey, have partially or totally collapsed due to column failure, whereas the more resistant apartment blocks, without open-ground storey, have no apparent structural damage. The building in Fig. 10f, located in the main street, suffered from soft-story collapse. Note that the glass façade of the building is almost intact. Other examples of damage to structures in Beichuan are collapse of soft stories as well as tilting and toppling of apartment blocks indicating ground failure (Fig. 10g,h). Throughout the city, survivors were still trying to recover their belongings from the damaged buildings and rubble at the time of our visit (Fig. 10a, e).

**Fig. 10** Building damage in Beichuan County Town. **a–b** Bei Chuan Hotel suffered severe damage, as failure of the column beam joints, but sustained the ground shaking. The main building of the hotel is clearly tilted (**a**). **c–e** Main street of the newer part of Beichuan, with collapse of weak structures due to column failure. **f–g** Buildings suffering single story collapse of the first floor. **h** Toppled building due to ground failure

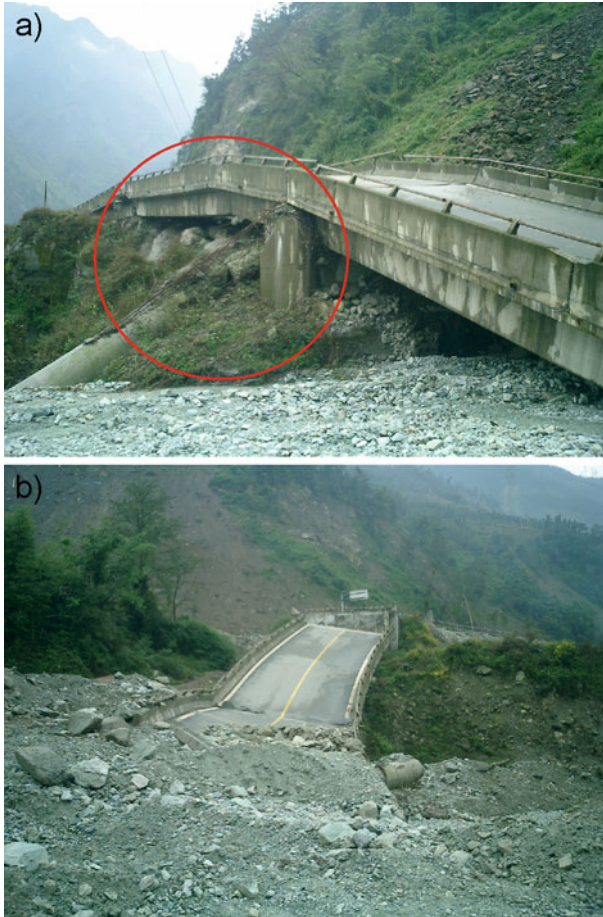
On the road from Chengdu to Yingxiu, the Baihua Bridge (“Hundreds of Flower” Bridge) collapsed at the entrance to Yingxiu (31.045°N; 103.474°E) due to failure of the bearing

columns (Fig. 11). The failure of the bridge further complicated the access to the area, hindering emergency rescue efforts.

**Fig. 11** Structural damage to the highway between Chengdu and Yingxiu. **a** View towards Chengdu. A collapsed column is visible in the lower left corner. **b** View towards Yingxiu, where the road section in the foreground is dislocated and separated from the section in the background

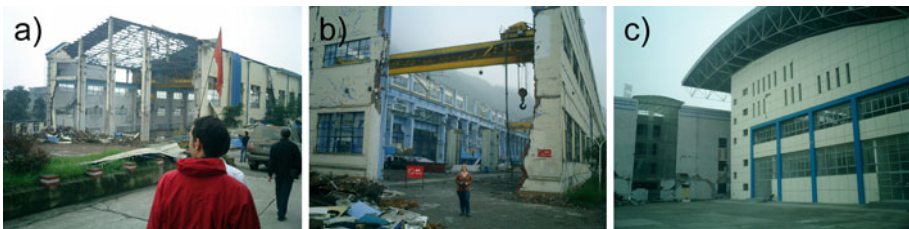
In the industrial city of Hanwang, the large-span buildings of the Dong Fang Steam Turbine Factory suffered varying degrees of damage (Fig. 12). The older brick buildings experienced roof collapse and partial collapse of walls. However, the main structure and the columns are intact and still standing (Fig. 12a,b). The gymnasium of the turbine factory, a steel-structure, was intact after the earthquake (Fig. 12c).

**Fig. 12** Factory buildings of the Dong Fang Steam Turbine Factory. **a–b** Older factory buildings, which suffered from substantial damage as roof collapse. **c** The gymnasium of the factory, which is a newer steel structure, had no apparent damage after the earthquake

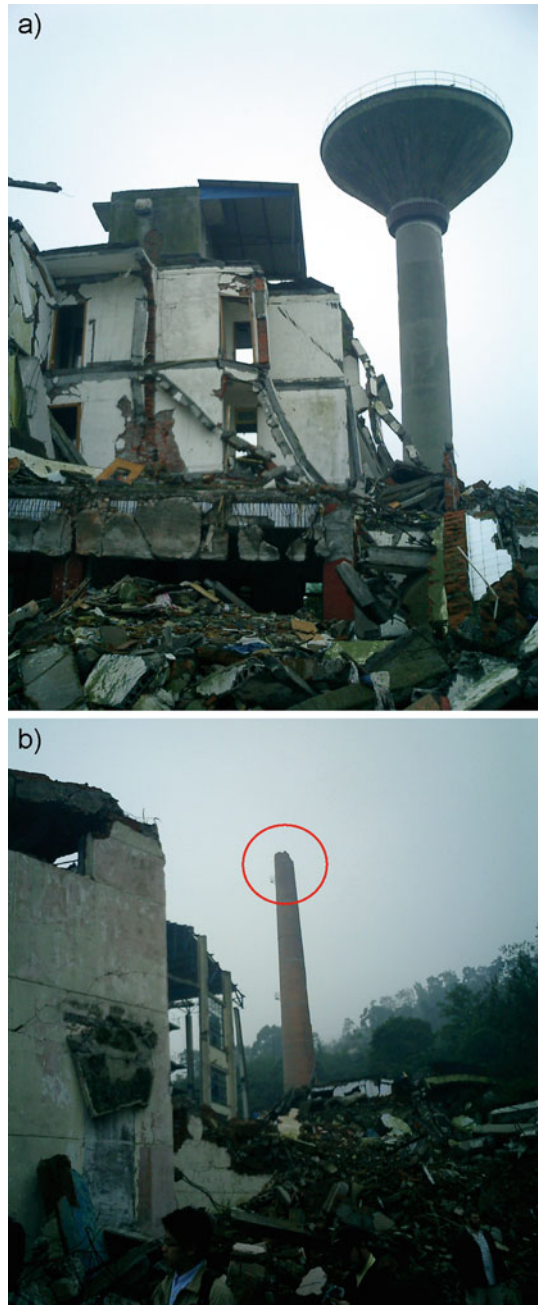
High-rise structures suffered varying degrees of damage. As an example, the water tower of the Shifang Cement Plant (located in Hanwang), approximately 15–20 m high and with a large mass on top (Fig. 13a), is intact after the earthquake, although nearby buildings were severely damaged. Figure 13b, on the other hand, shows another factory in Hanwang where the chimney has been damaged near the top. The nearby factory buildings have been heavily damaged, with partial collapse of some walls. Also long-span structures, such as bridges and dams, experienced varying levels of damage. Damage to bridges varies from total

**Fig. 13** High-rise structures. **a** Water tower of Shifang Cement Plant in Hanwang. **b** Slightly damaged factory chimney in Hanwang

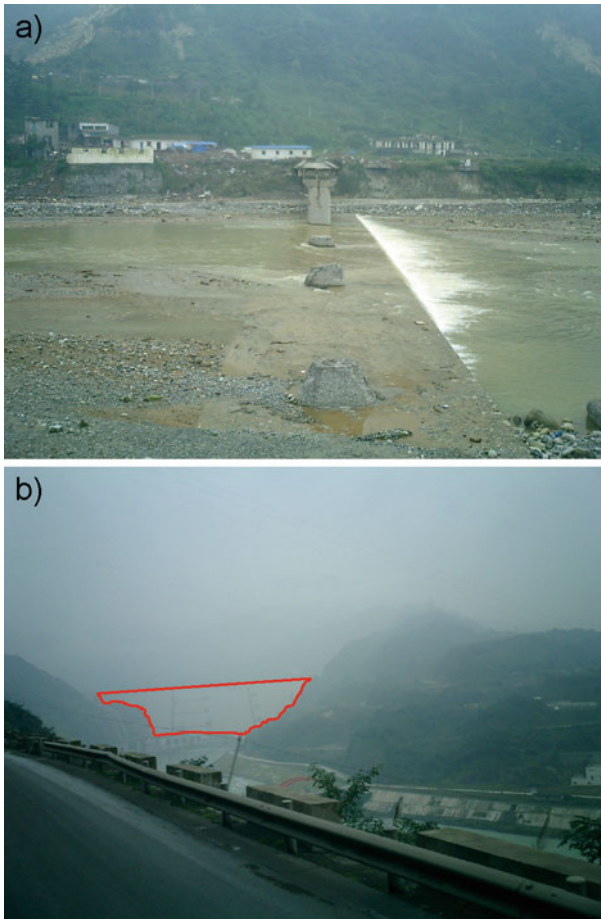
collapse, such as an older bridge located near the surface rupture in Hanwang (Fig. 14a), to no damage. The Zipingpu Dam was slightly damaged due to displacement of the dam (vertical settlements of 73 cm and horizontal displacements of 38 cm have been observed after

the earthquake) (Zhang et al. 2009). However, the main structure of the dam remained intact (Zifa et al. 2008) (Fig. 14b). Construction of the Zipingpu dam was completed in October 2005, and the reservoir reached a water level of 875 m above sea level in October 2006 and again in November 2007 (Zhang et al. 2009). Several authors have discussed whether this

**Fig. 14** Long-span structures. **a** Bridge crossing the river in Hanwang, notice that the foundation of the bridge has no apparent damage. **b** Zipingpu Dam. The silhouette of the dam structure is barely seen in the background, marked with a red line. Picture is taken upstream towards north

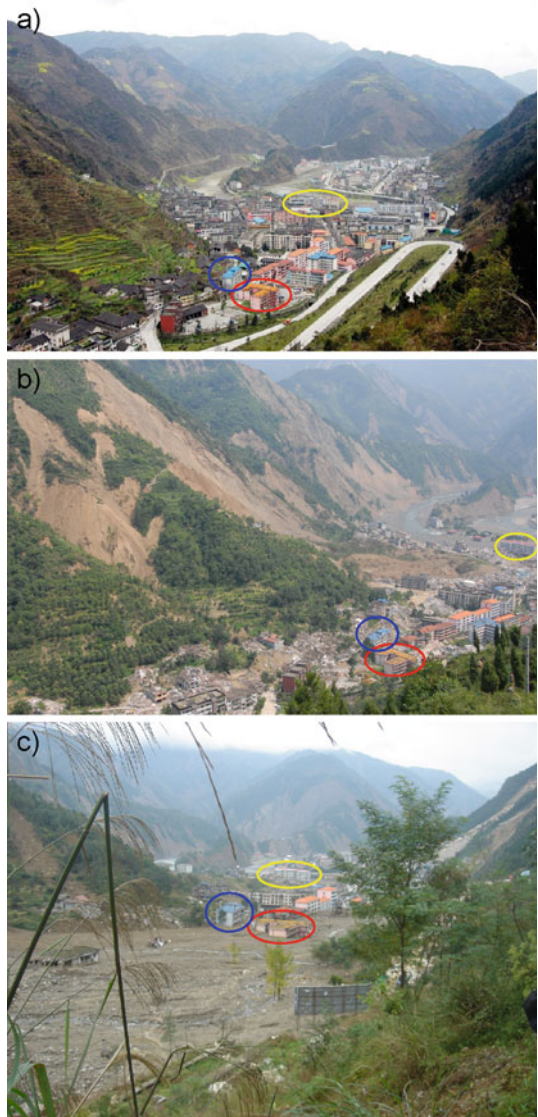
Numerous secondary effects have been documented and there are at least 15,000 instances of landslides, rock falls, debris flows and mudslides. These effects are estimated to have caused more than 20,000 fatalities ([Yin et al. 2009](#)). This is seen clearly at Beichuan. The city sustained heavy damage due to strong ground shaking from the main shock and later by aftershocks. Additional damage was caused by the following landslides and rock falls from the steep mountains that surround the city. The area was further impacted by a widespread debris- and mudflow on September 21, 2008. Figure 15 shows Beichuan before and after the earthquake, as well as after the debris flow. Houses can be identified in the three pictures for correlation. The extent of the debris flow was widespread and comparing Fig. 15b,c clearly

**Fig. 15** Overview of Beichuan County Town. **a** Photo of the town Beichuan before the May 12, Wenchuan earthquake (photo source unknown). **b** Photo of the town Beichuan, taken in July 2008, after the May 12 Wenchuan earthquake. (Photo by Dr. Gonghui Wang, Kyoto University, Japan). **a** and **b** are from the homepage of [USGS Landslide Hazard Program \(2009\)](#). **c** Photo of Beichuan, taken in October 2008, after the debris- and mudflow

shows how the area is overlain by debris material and further damaged by the debris flow. More examples from the Beichuan area are presented in the following paragraphs.

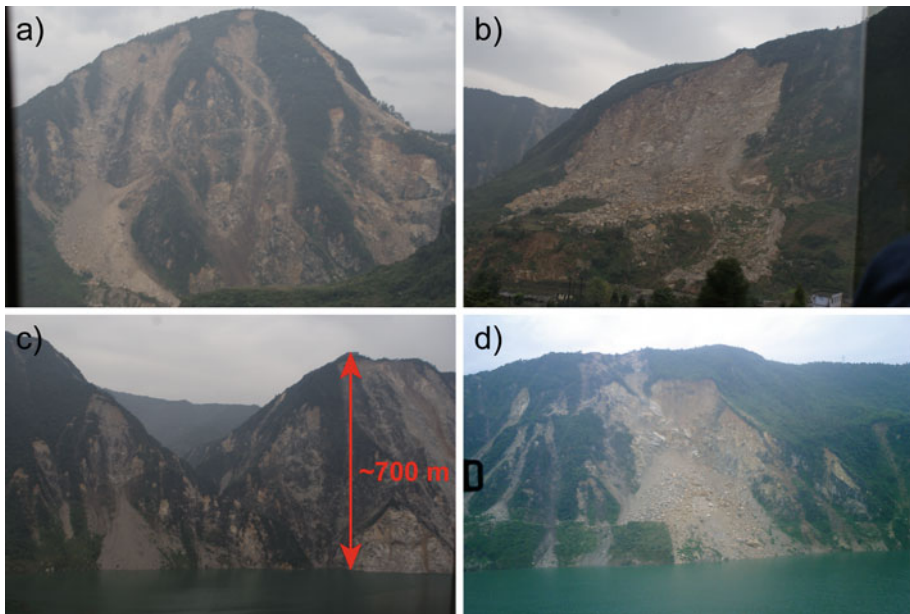
**Fig. 16** Landslide scarps near Yingxiu. The vertical distance from the water level to the top of the mountain is in these pictures roughly estimated to be 700 m. **a–b** Landslide scarps visible from the road towards Yingxiu. **c–d** Landslide scarps at the hills surrounding the water reservoir of Zipingpu Dam

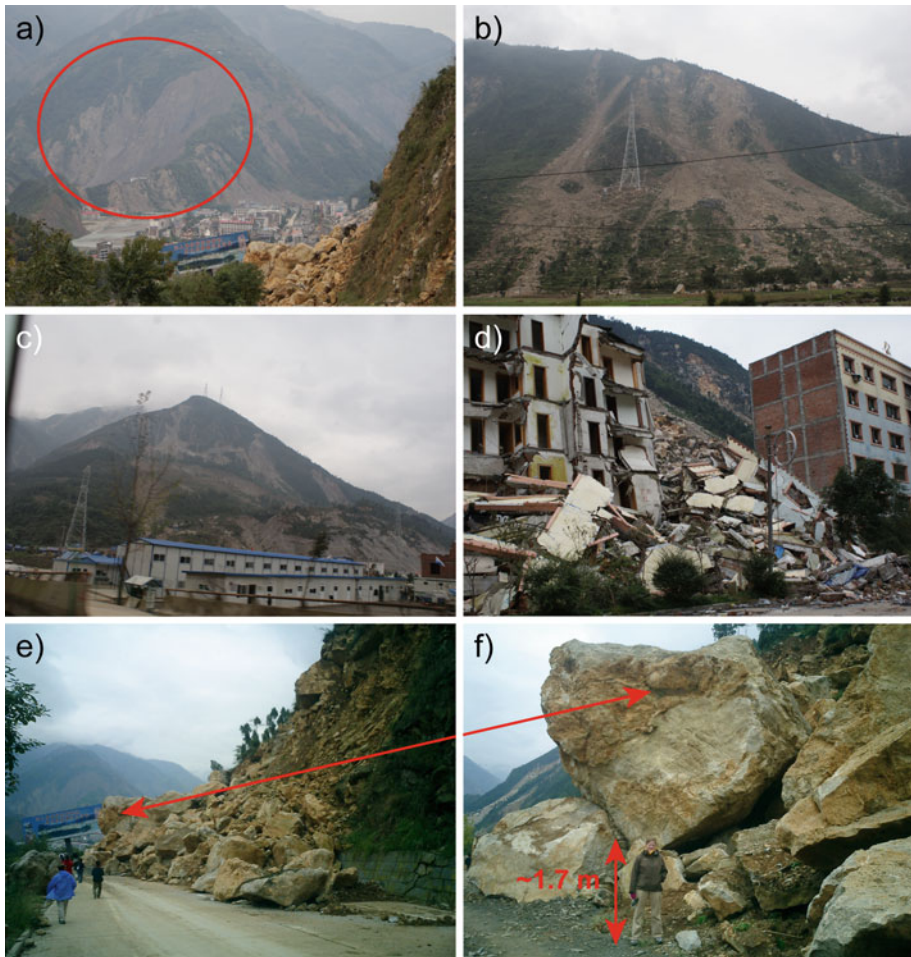
Similarly, Beichuan is surrounded by steep mountains, and the city sustained significant damage as a result of a large number of landslides and rock falls (Fig. 17). Large volumes boulders and large blocks have caused severe damage both to infrastructure (blocking roads and tearing down communication lines) and to buildings in the city. Several landslide scarps were visible in the city (Fig. 17a–c). We saw several structures in the city, which appeared to have withstood the strong ground shaking but were later destroyed by the triggered landslides. An example of this is shown in Fig. 17d, where an apartment building is completely destroyed by a landslide, while the two neighboring buildings are still standing, one of them without any apparent structural damage. Also, large blocks from the rock falls caused damage to the infrastructure blocking the roads leading in and out of the city (Fig. 17e,f).

**Fig. 17** Landslides and rock falls in Beichuan. **a–c** Landslide scarps visible on the steep mountain slopes surrounding Beichuan. Temporary shelters are visible in the foreground of **(c)**. **d** Landslide in the center of Beichuan, causing an apartment block to total collapse. To the right a building with no apparent damage is visible. **e–f** Large rock falls and boulders blocking the road to Beichuan, notice the huge size of the boulder in **(f)**

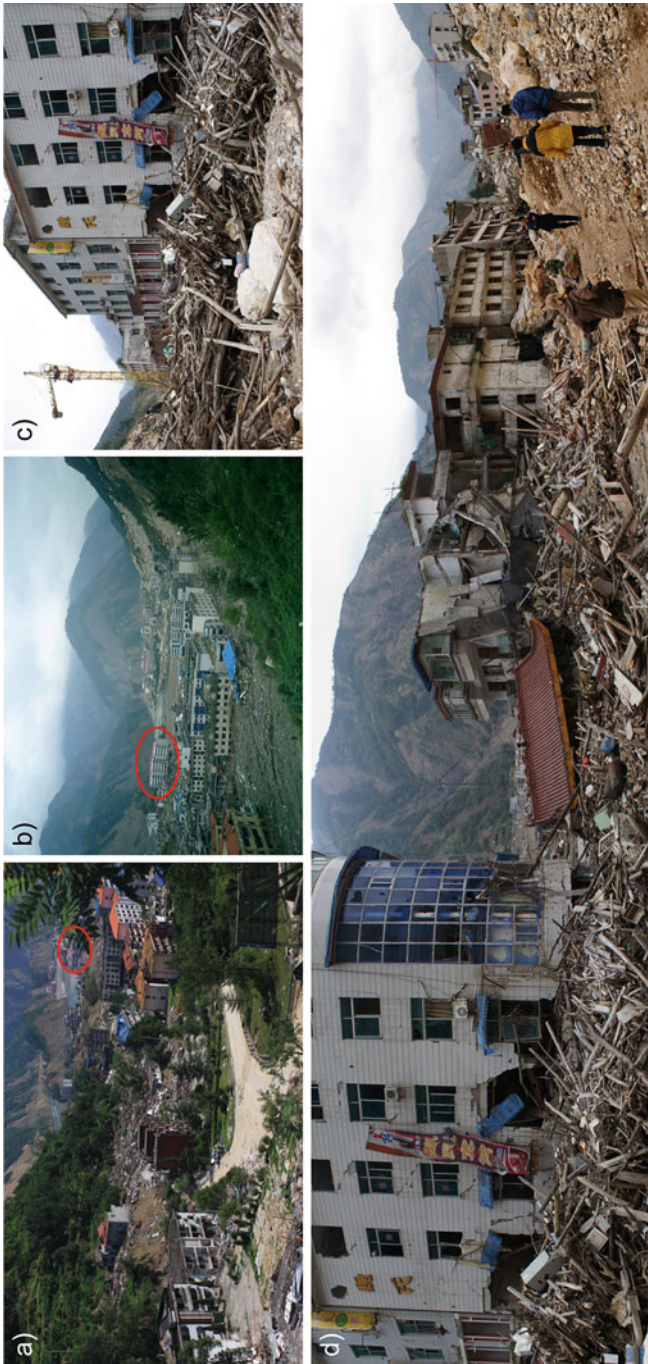
On September 21, 2008, Beichuan was struck by a large debris- and mudflow which covered the SW part of the city with up to 3 m of debris material and mud (Fig. 18). The debris flow did not cause further structural damage to the buildings in the area (comparing Fig. 18a,b). However, the roads in the city were covered by the large amount of debris material and mud, making it difficult to get around in the city. Broken trees were brought to the city from the mountain sides, creating a natural dam (Fig. 18c,d). Houses located in the debris flow area had diagonal cracks in the walls caused by the strong ground shaking during the earthquake

(Fig. 18c). In the older part of the city, towards the river, there was a large row of damaged houses surrounded by debris material, where rubble from damaged structures has been transported to the central part of the city during the debris flow (Fig. 18d).

**Fig. 18** Debris- and mudflow in Beichuan. **a** Overview of Beichuan after the earthquake, but before the debris flow (Reprinted by permission from Macmillan Publishers Ltd: [British Dental Journal] (Dai et al. 2009), copyright (2009)). **b** Overview of Beichuan after the earthquake. The red circles mark the same building in (a) and (b) for correlation. **c–d** Natural dam created of broken trees and building material brought to the city by the debris flow. Diagonal cracks in the walls caused by strong ground shaking are visible

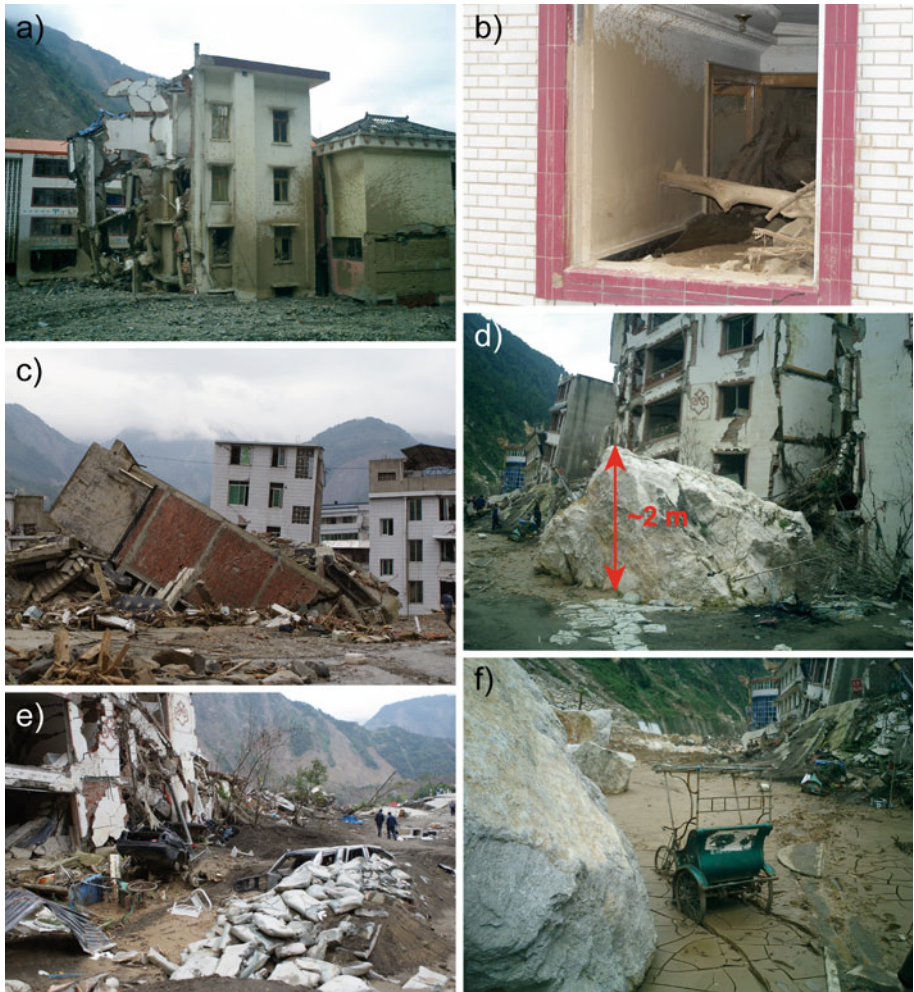
The strength of the debris- and mudflow was evident by the many splatter stains of mud on the in- and outside the buildings within the debris flow area. Tree trunks inside the buildings indicate that the debris flow penetrated houses (Fig. 19a,b). The structural damage to the buildings, as well as tilted or toppled houses within this area, were probably caused by the strong ground shaking during the earthquake rather than the debris flow. Due to the huge amount of debris material covering the area, the lower floors of the buildings were buried in mud (Fig. 19a,c and d). Within the debris flow area, large rock bodies, which have fallen from the mountain sides, as well as cars and other objects, were visible (Fig. 19d–f).

**Fig. 19** Debris- and mudflow in Beichuan. **a–b** Splatter stains of mud on outer and inner walls of houses in the debris area verifying the strength of the event. **c** Toppled building in the old part of Beichuan due to ground failure during the ground shaking. **d–f** large boulders, cars and other objects stuck in the thick layer of mud and debris material. In **d** and **e** buildings with extensive damage due to strong ground shaking is visible

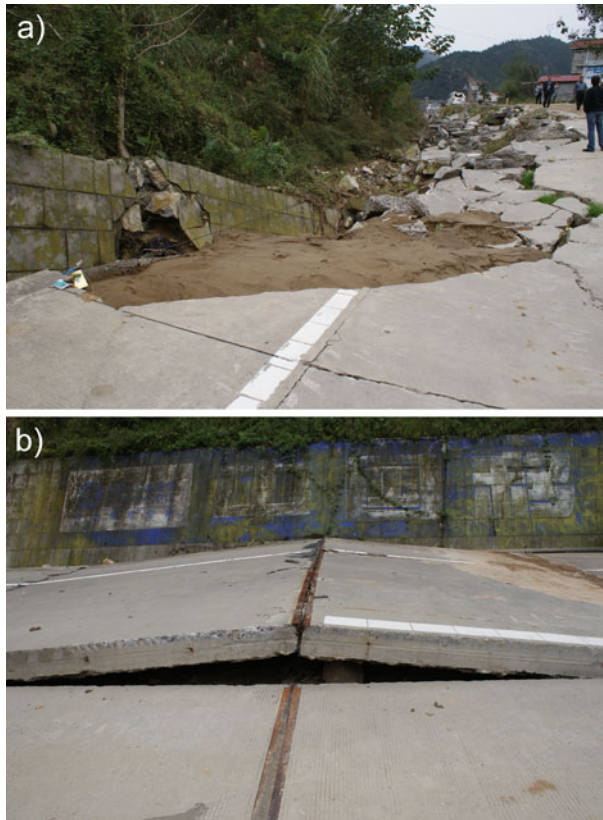
Several observations of liquefaction during the Wenchuan earthquake have been reported along the fault rupture (Zifa et al. 2008). During the field trip, we observed indicators of liquefaction near Beichuan (Fig. 20a). Here, a wall along the road has sunk into the liquefied sand and the concrete road was broken in a large area due to the liquefied base. The roads were in many places constructed of large concrete blocks, these were often fractured or suffered from buckling (Fig. 20b).

**Fig. 20** **a** Evidence of liquefaction, where the wall and road has sunk into the sand. **b** Buckling of concrete road blocks
