## Damage tolerance of six dental zirconias with different translucencies

Cathrine Å. Karlsen , Christian Schriwer & Marit Øilo

### ABSTRACT

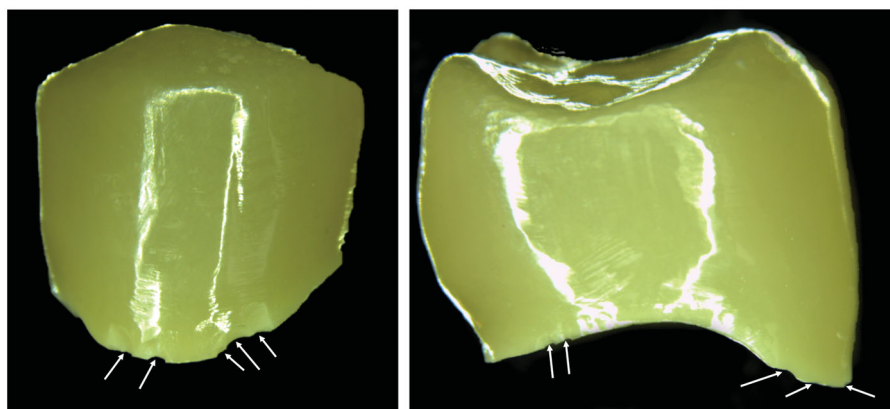
**Figure 1.** Two examples of ultra-translucent monolithic zirconia crowns delivered from a dental technician with multiple margin flaws (white arrows). These flaws were considered to be due to poor packaging during shipment.

with a reduction of the content of alumina (Al<sub>2</sub>O<sub>3</sub>) affect light transmission through the material, but also the fracture strength [1,2,4,11]. There is limited documentation on whether other mechanical properties are affected or not [12]. Personal experience and communication with dentists and dental technicians indicate that margin chipping is more frequent with the ultra-translucent materials (Figure 1). Margin damages can be detrimental for crown strength [13–16].

[14,18–20]. This is in accordance with the clinical experience as shown in Figure 1 and previous studies [1,12,21–23]. How this eventually will affect clinical success is uncertain. It is reasonable to assume that poor damage tolerance reduces fracture resistance and clinical survival time. Furthermore, margin chippings will create uneven margins with increased risk of plaque retention and thus the risk of secondary caries and gingivitis [24]. This should be taken into consideration when setting the machining protocols for the different materials.

The present study has some limitations as it only addresses short-term effect of one aspect of fracture initiation of dental zirconia. Aging or dynamic loading has not been taken into consideration either. The number of specimens is limited, but given the low standard deviation and the large differences in results the likelihood of making a type II error of clinical significance is low. The results cannot fully explain the cause of the early failures seen in Figure 1 and further investigations are necessary.

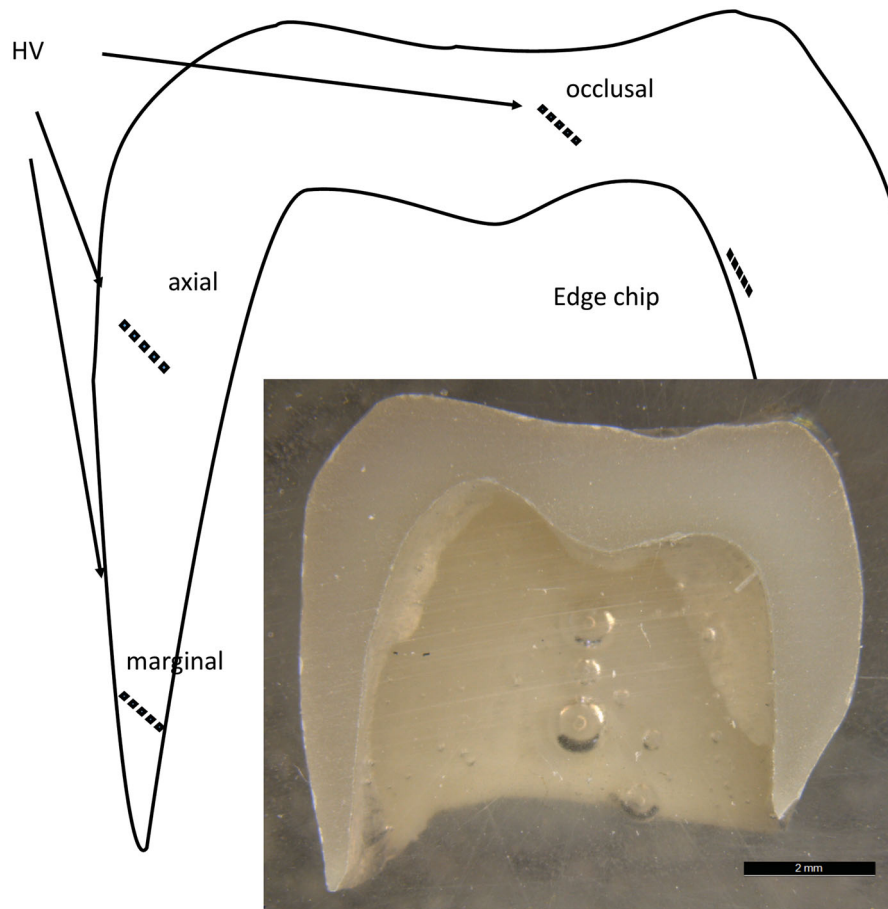
**Figure 2.** Premolar monolithic crowns embedded in epoxy and cut in half were used for the study. Three regions (marginal, axial and occlusal) were analyzed in each crown.

The crowns were mounted in epoxy molds (Epofix, Struers, Ballerup, Denmark) and the specimens were cut to a flat surface with a diamond cutter of 220 grit as a cross-section of the crown (Figure 2). The surfaces were polished to a high gloss finish in an automatic polishing unit (Tegrapol-11, Struers, Ballerup, Denmark). The polishing sequence started with one minute with a diamond disk of 1200 grit with 10 N pressure and 330 rpm, followed by 2 min with 10 N pressure and 150 rpm with 5 µm diamond paste and 2 min final polishing (3 µm) at 150 rpm. After each step, the crowns were thoroughly rinsed in an ultrasonic bath with soap (Deconex 2%) for ten minutes and steamed clean.

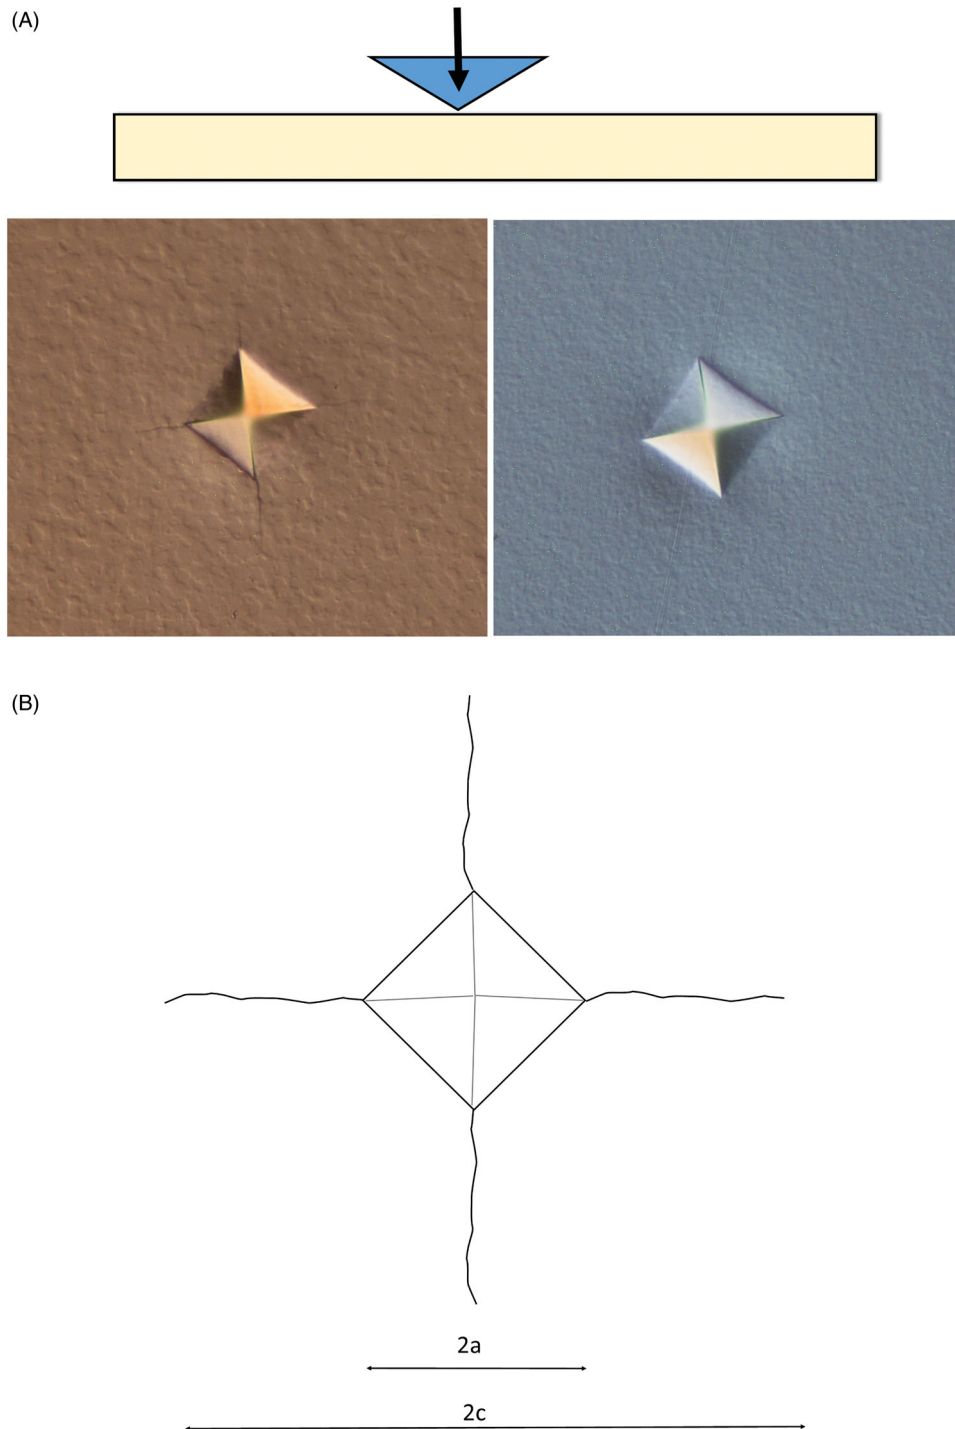
**Figure 3.** Illustration of the hardness test (A) and the measurement performed (B).  $2a$  is the diagonal length of the indent and  $2c$  is total crack length.

was performed on each crown (Figure 3(A)), five in the marginal region with wall thickness < 0.5 mm, five in the axial wall region with wall thickness between 0.5 and 1 mm and five in the occlusal wall region with wall thickness over 1 mm. Both the diagonal length of the indent and the crack propagating from the indent corners were measured and used in the analyses (Figure 3(B)). The ratio between the crack length and the diagonal length of the indent ( $c/a$ -ratio) was used as an indicator of damage tolerance. For each location, the mean of the five measurements was registered giving 15 separate values for each test group which was used in the analyses. A series of indents were made gradually closer and closer to the half-cut crowns' inner walls until a chip was made as an experimental edge chip method [17]. The distance between the 90-degree angle of the test surface and inner wall of the first indent to create an edge chip was measured.

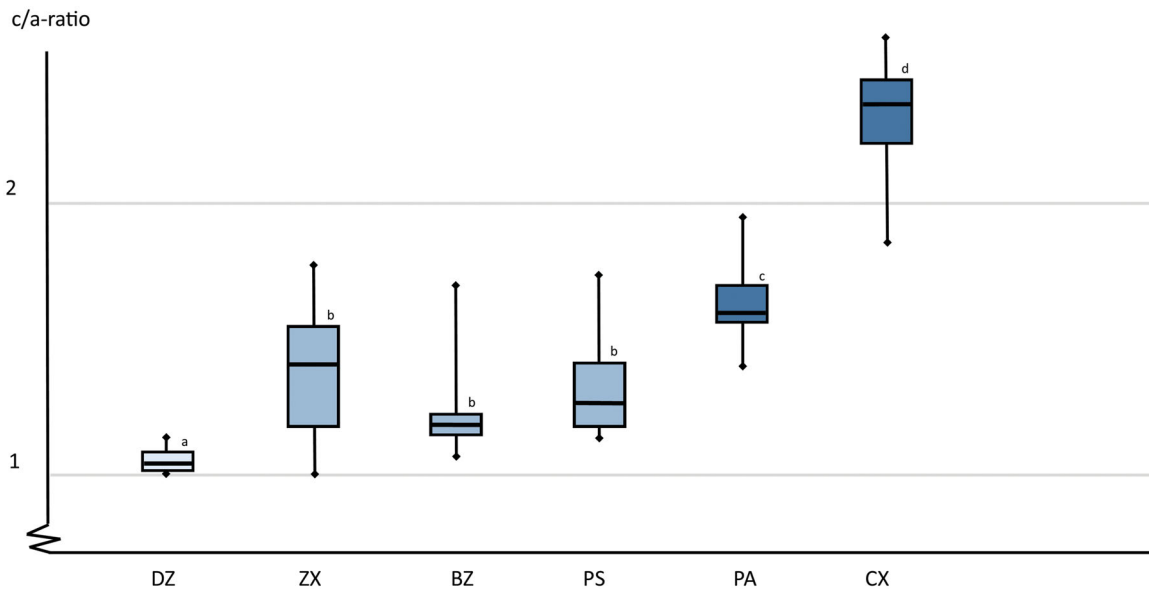
**Figure 4.** A box plot of the crack/indent-ratio ( $c/a$ ) for the different test groups. Boxes marked with identical superscript letters and not statistically significant different form each other. Horizontal lines represent median values, the boxes represent the interquartile range and the whiskers indicate maximum and minimum values. Boxes marked with same letter are not statistically significant different form each other.

(Figure 4,  $p < .001$ ). The hard-machined 3Y-TZP material (DZ) had the best crack propagation resistance and the two soft machined materials with  $\geq 5\text{mol\%}$  yttria content (PA and CX) had the lowest crack propagation resistance. There were no differences between the two batches of the ZX material, these groups are therefore presented as one group in the following presentations. There were no differences in hardness or *c/a* ratio in the different locations of the crowns, cervical, axial or occlusal.

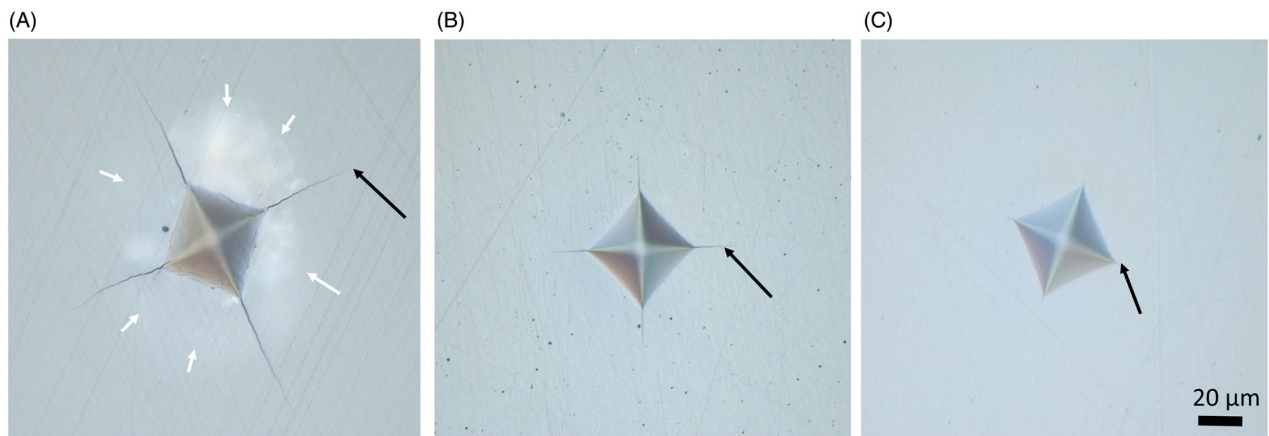
**Figure 5.** Examples of the variation of the damage zone around the indents as seen in the light microscope. (A) High Yttria content, (B) moderate yttria content, and (C) low yttria content. The arrows indicate end of crack.

The damage zone around the indents varied greatly, from no visible damage in the hard-machined zirconia (DZ) to large areas with crushed surface in the two high yttria content (PA and CX) materials (Figures 5 and 6). There were apparent differences among materials in the distance required to withstand an indentation without fracture, but it was difficult to measure the distance to the edge with sufficient precision due to large crushing damages (Figure 7).

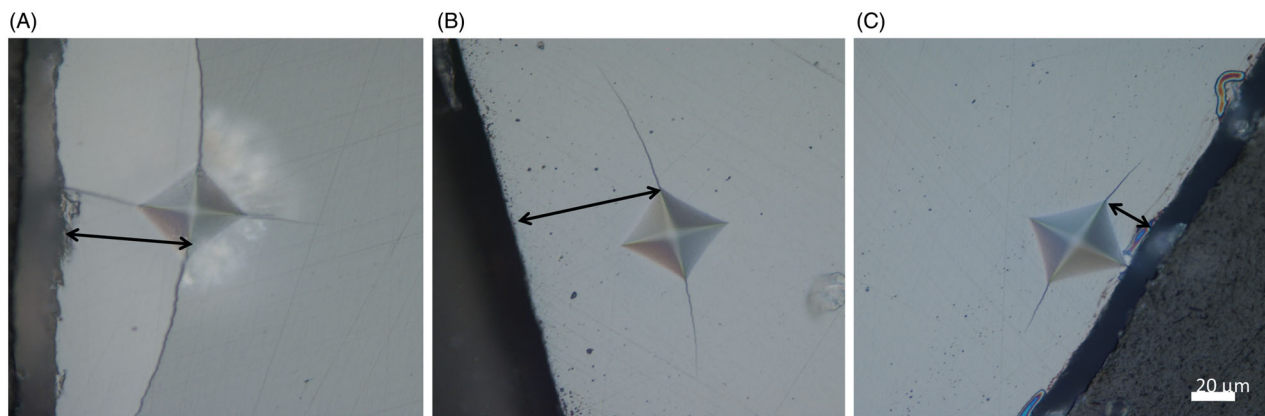
**Figure 7.** There was apparent differences in how close to the edge an indent could be placed before causing a chip. (A) High yttria content, (B) moderate yttria content, and (C) low yttria content. Arrows indicate distance from the edge.
