Monolithic zirconia crowns in the aesthetic zone in heavy grinders with severe tooth wear – An observational case-series

ABSTRACT

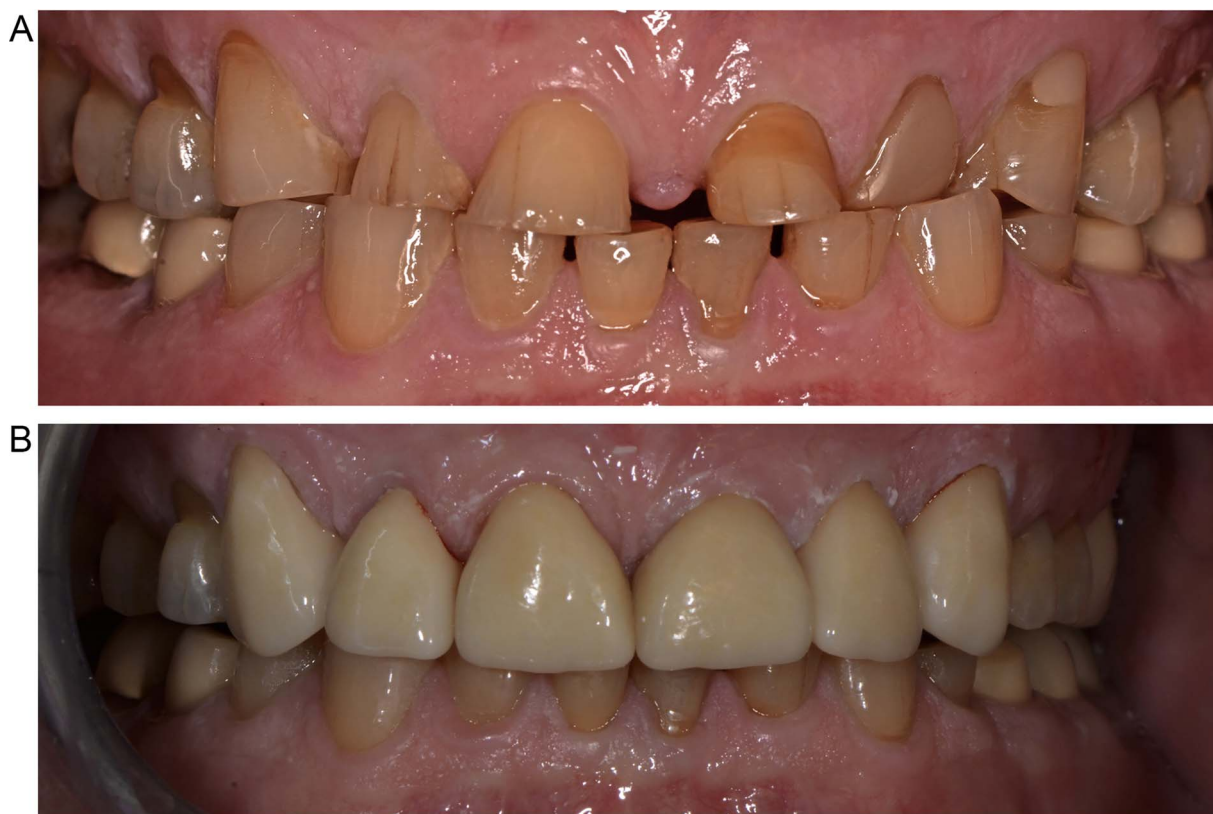
Fig. 1. A) Before treatment: Clinical photo of a typical patient with severe tooth wear in the aesthetic zone. B) After treatment: Clinical photo of monolithic zirconia crowns with a 3 years follow-up time.

- Severe tooth wear in the aesthetic zone.
- The patient preferred strength and durability of the restorations as compared to aesthetics.
- All teeth in need of treatment had been restored with monolithic zirconia single crowns (BruxZir®, Glidewell Laboratories, USA) and cemented with resin modified glass ionomer cement (Fuji plus®, GC Corporation Tokyo, Japan) (Fig. 1).
- The patients did not wear an occlusal night guard after treatment.

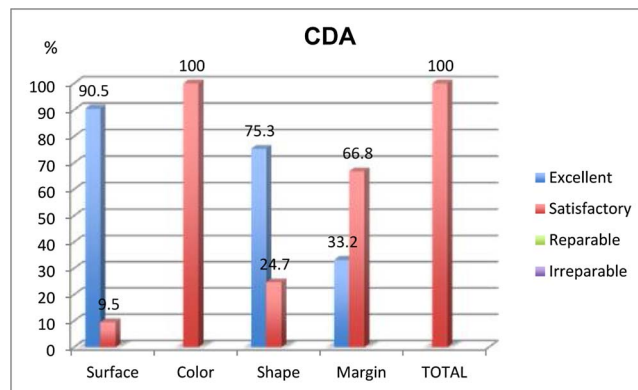
Fig. 3. A 3D-bar graph presenting clinical ratings of the crowns according to the modified CDA-scale. The bars are representing the results in percentage of the total.

Almost all of the crowns (90.5%) had excellent surfaces and the rest was evaluated as satisfactory. The color was rated as satisfactory on all

crowns. Most of the crowns (75.3%) had excellent shape whereas the remaining were evaluated as having a satisfactory shape. The crown margins were excellent in the majority of the crowns (66.8%) and satisfactory on the rest. Overall, all crowns were evaluated as 100% satisfactory and not in need of repair or remake regarding any of the CDA variables (Fig. 3). Inter-examiner agreement on the CDA ratings was 87.2% (range 75–100).

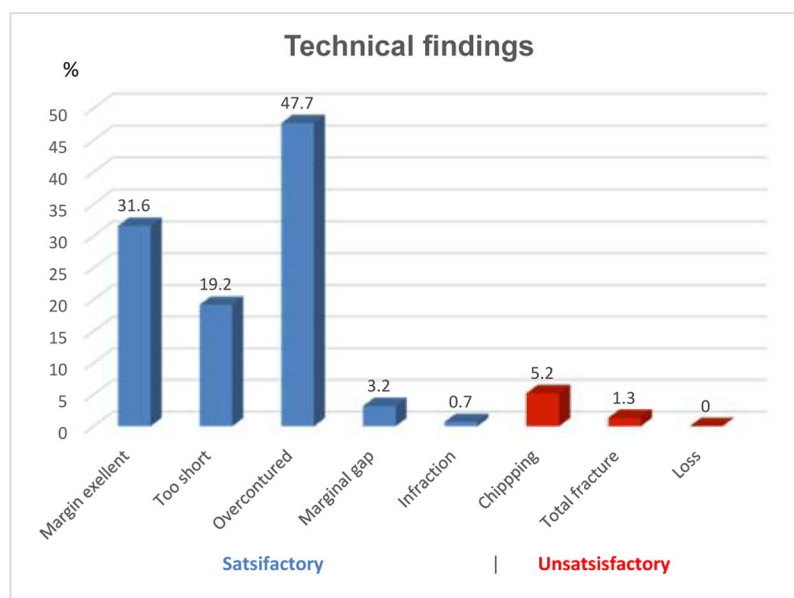
Fig. 4. A 3-D bar graph of technical findings and complication details of the crowns. The bars are representing the results in percentage of the total.

Approximately 1/3 of the crowns had excellent margins, 1/5 of the crowns had slightly too short margins, and almost half of the crowns were slightly over-contoured (Fig. 4). One examiner found marginal gap on four crowns, and a possible infraction was registered in one crown. The majority of the crowns ($n = 80$, 94.1%) showed no signs of chipping. However, one patient had incisal chippings on four crowns (Fig. 5). The chippings occurred 1 month after the crowns were cemented. The fracture origins were from roughened areas on the palatal side on the incisal edge. One crown, in another patient, had a total fracture after 16 months and was replaced. The fracture origin was a defect in the crown margin in the mesial region causing a semilunar fracture on the buccal surface (Fig. 5). No other crowns were lost. Inter-examiner agreement on technical findings was 89.9% (range 72,2–100).

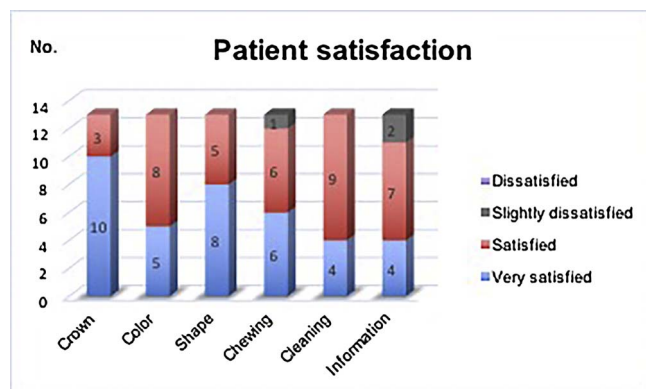
Fig. 6. A 3D-bar graph of patient reported outcomes according to the self-administered questionnaire. The bars are representing the distribution of the sample expressed in color codes.

All 13 patients were satisfied with the monolithic zirconia crowns; indeed, the majority was very satisfied (Fig. 6). Hence, none of the patients reported dissatisfaction with the crowns. Regarding color, eight of the patients were satisfied and the rest were very satisfied. Five of the patients were satisfied with the shape of the crowns, whereas the rest were very satisfied. Six of the patients were very satisfied and equally many were satisfied with the chewing comfort. One patient reported to be slightly dissatisfied with the chewing comfort. All patients were satisfied with the cleaning accessibility of the crowns; four were very satisfied, the remaining was satisfied. Seven patients were satisfied and four were very satisfied with the preoperative information. Two patients were slightly dissatisfied with the preoperative information. Two patients reported some problems with their crowns; the patient who experienced chippings and the patient with one total fracture. Both these patients reported to be satisfied or very satisfied with all the self-reported variables. The remaining 11 patients reported no problems with the crowns. All patients would choose the same treatment modality if they were to be treated again.
