## *The fortifications at Kastro Apalirou*

Håkon ROLAND

## *Introduction*

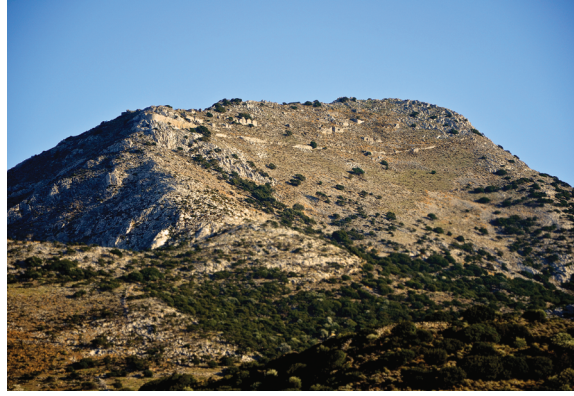
Figure 1. Overview of Kastro Apalirou.

From a distance, the most striking feature of Kastro Apalirou is the impressive wall encircling the upper part of the steep mountain slopes (**fig. 1**). At the northern tip, a large round tower and imposing wall structure is visible, which is also the first and largest structure that visitors see when ascending the mountain. When viewing the mountain from a distance one can be led to believe that there are several concentric lines of walls ascending the slope towards the peak. However, this is due to the large, solidly built cisterns that are distributed across the site; in the northern part they are constructed alongside each other, forming a line of walls that gives the impression of a defensive wall when seen from a distance.

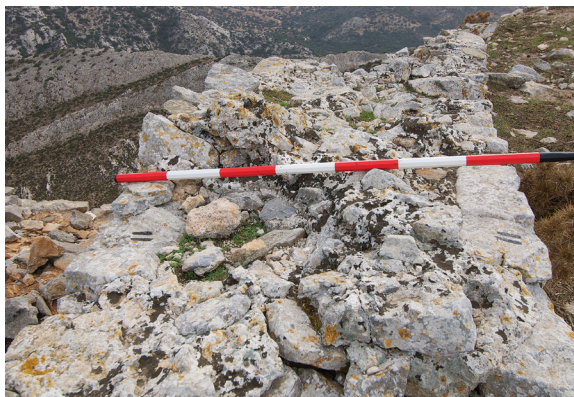
Figure 3. Narrow part of the wall (1.40 m) heavily mortared behind tower on the east side. A on fig. 2.

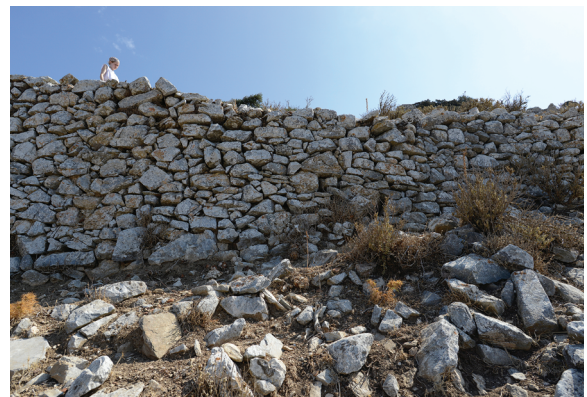
Figure 4. Masonry type 1.B on fig. 2.

A close survey and documentation of the surviving parts of the defences has revealed three main types of masonry: Type 1 consists of uncoursed dry stones with virtually no use of mortar. The stones are mostly unworked or roughly hewn, although dressed quoins are seen especially in the towers. (**fig. 4**). Type 2 is roughly coursed (with variations) and has undressed stones with extensive use of smaller, flat stones and broken tiles for coursing and stability. The stones are worked to form a rough, but fair faced outer surface. A moderate use of mortar is seen in places. This type of masonry is also seen in some of the larger houses, and in the repair of damages in older walls and buildings (cf. below) (**fig. 5**). Type 3 is uncoursed and made up of sharply cut stones of irregular size, however worked to form a fair face. This part of the wall is bonded with grey mortar, occasionally with the surface almost completely washed rendered with mortar. Type 3 is used first and foremost for the bastion, but also in a few larger cisterns and vaulted basements of larger houses (**fig. 6**).

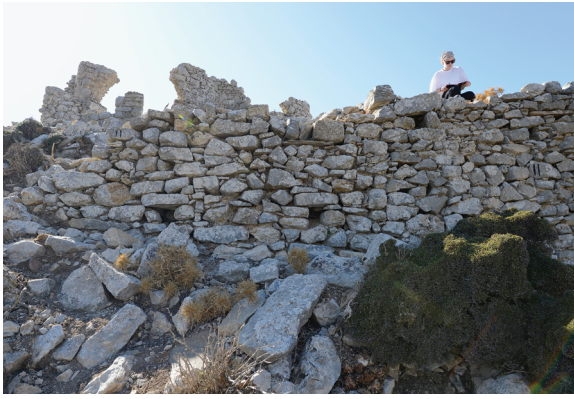
Figure 5. Masonry type 2. C on fig. 2.

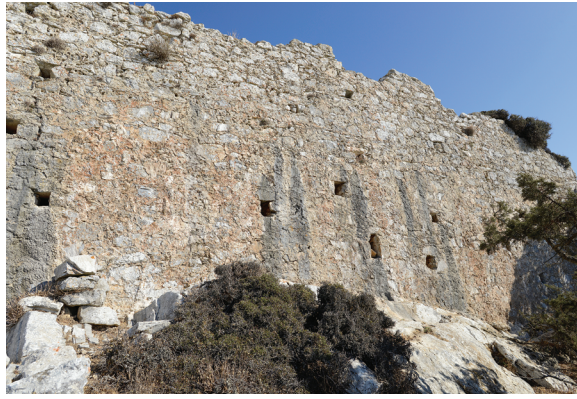
Figure 6. Masonry type 3. D on fig. 2.

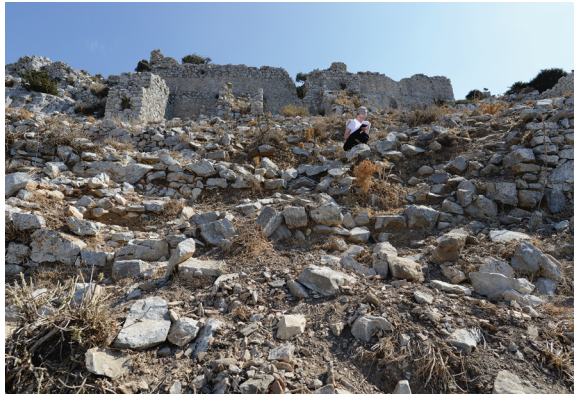
Figure 7. Foundation of (collapsed) tower. E on fig. 2.

No parts of the wall have so far been excavated, and thus no satisfying vertical cut is available for studying the method of construction or the interior of the walls and towers. However, over the past years some sections of towers and walls have collapsed so that some observations can be made: Mortar is only used in some parts of the interior of the wall, and only to a minor degree. Rubble, gravel, and occasionally soil and larger stones (probably waste from stone cutting) make up the fill. Due to the steepness of the site, the major part of the defences is located on terrain that inclines between 20 and 45 degrees. It seems probable that the earliest parts of the wall were constructed mainly of dry stones, without binding mortar or tiles/flat stones applied for stability. This rules out the possibility of using tiles and mortar for a stabilising fundament as observed elsewhere, e.g. in the rebuilt parts on the northern edge running down towards the bastion.<sup>11</sup> Successive terraces of larger stones, with infill of gravel, soil and occasionally earth bonding seems to be the preferred method of foundation of the walls and towers at Apalirou (**fig. 7**).

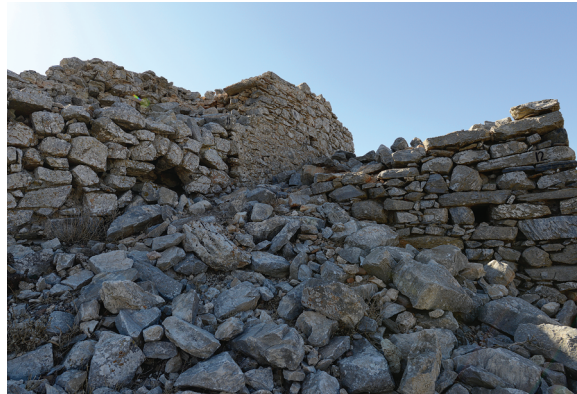
Figure 8. Enforced back wall of tower. F on fig. 2.

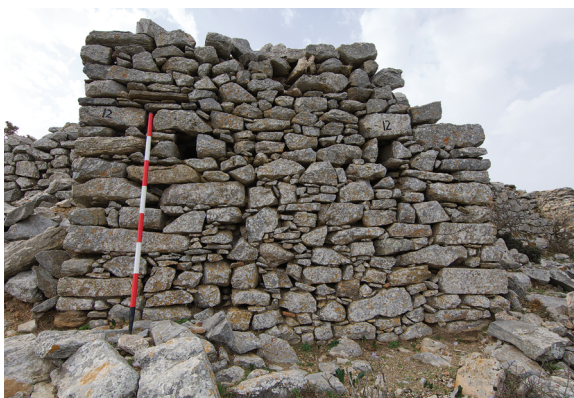
Figure 9. Front of tower on north-eastern side. G on fig. 2.

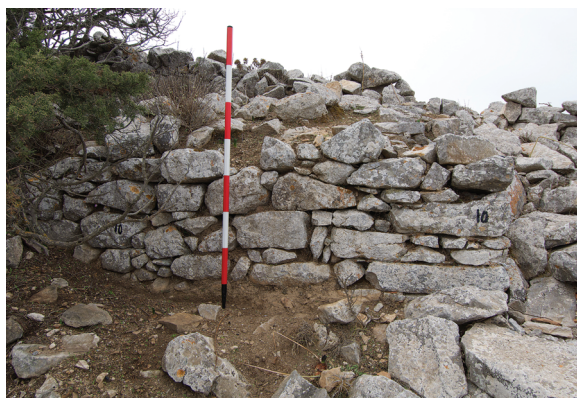
Figure 10. Drystone wall on eastern side. H on fig. 2.

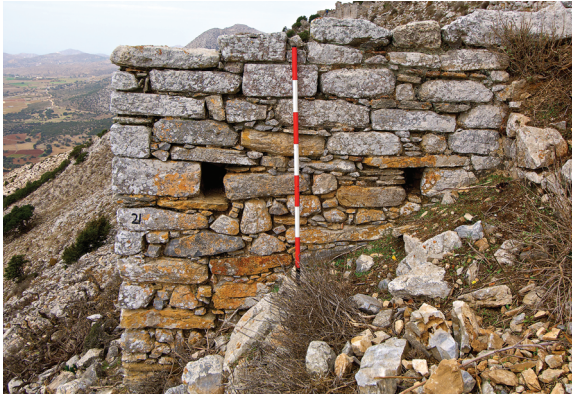
Figure 11. Tower on the western side. I on fig. 2.

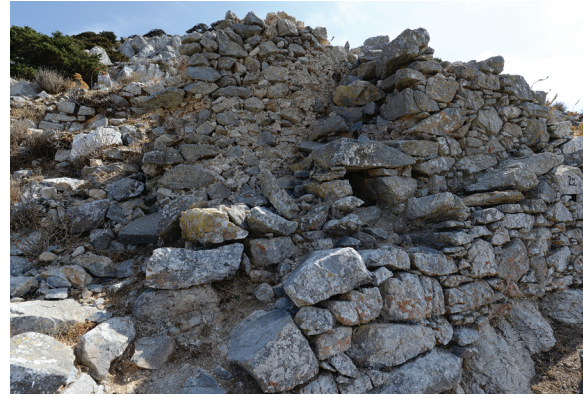
Figure 12. Tower on the south-western edge. J on fig. 2.

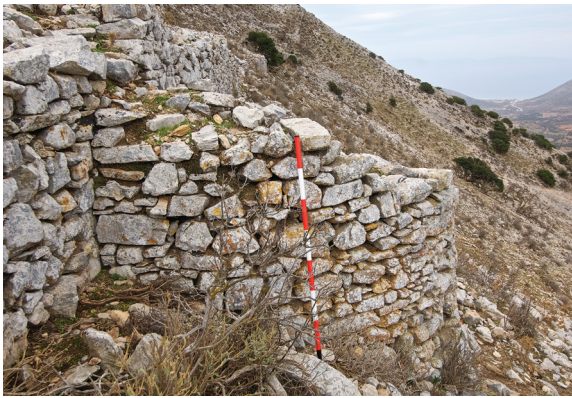
Figure 13. Semicircular tower on the north-western side.  
K on fig. 2.

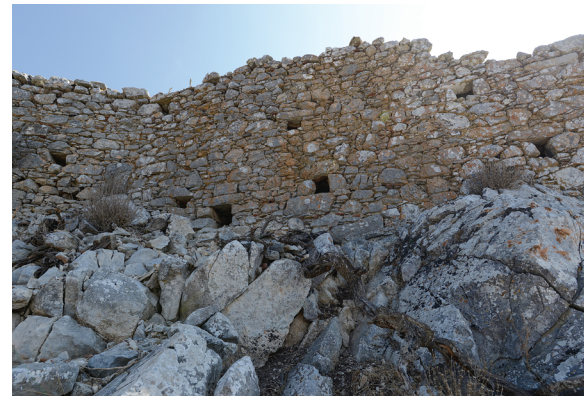
Figure 14. City gate, front to the west. L on fig. 2.

The main gate is located just south of the centre on the western flank. Seen from the northern side there is first an extension out from the main wall, creating a 4.0 m wide and 5.10 m long platform adjacent the gate proper. This platform extends into a wall that continues 5.50 m southwards at a 30-degree angle to the main wall (**fig. 14**). At the end, the wall turns 90 degrees towards the main wall, which is reached again on the south side of the gate after 5.50 m. One meter from the outer corner a 1.90 m opening defines the entrance to the Kastro (**fig. 15**). The upper part of the gate (and wall) has collapsed, and the original height is unknown. Maximum standing height of the remaining parts today is 3.50 m. The steps leading from the entrance up to the level inside the fortified site are completely ruined by the collapsed upper parts of the gate. The northern extension of the wall creates a square platform or podium that fits perfectly the standard measure of the other, square towers. The area in question is too degraded to be able to draw firm conclusions, but it seems likely that a square tower was located here. This would be expected due to what is observed from similar gateways set at right-angles to the curtain wall. The bent entrance also provided additional security, as any attackers would have been forced to approach the gate under assault from the flanking wall. There are no signs of a postern at Apalirou as can be seen e.g. at the south side of Emporio. However, Apalirou has an inverted entrance while the gate at Emporio is a simple one. Maybe this can be seen as indicative of the greater status of Apalirou.<sup>13</sup>

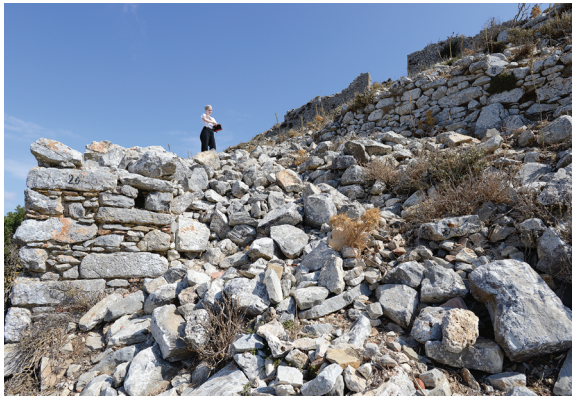
Figure 15. City gate, entrance. M on fig. 2.

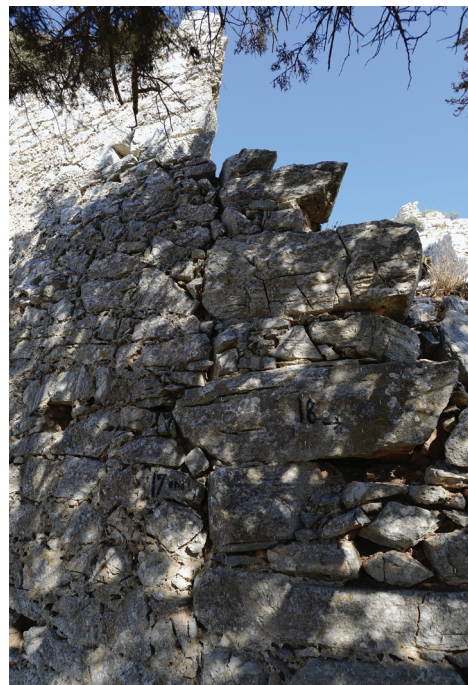
Figure 16. Junction between the bastion and curtain wall  
running southwards. N on fig. 2.

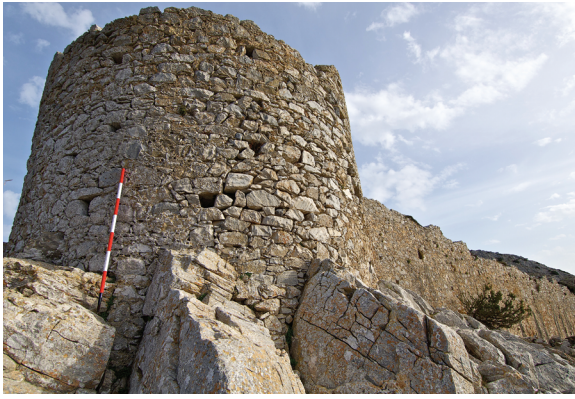
*Figure 17.* Bastion. O on fig. 2.

edge is presently the most visible part of the defences on Apalirou (**fig. 17**). It is also the lowest part of the Kastro. South of the bastion, the curtain is also of a newer construction and runs for 38 m until a few meters before the curtain meets the semi-circular tower. In this part, the masonry consists of a variety of stone sizes, differently hewn, from ashlar to small angular stones with and without mortar bonding, indicating a rebuild (**fig. 18**).

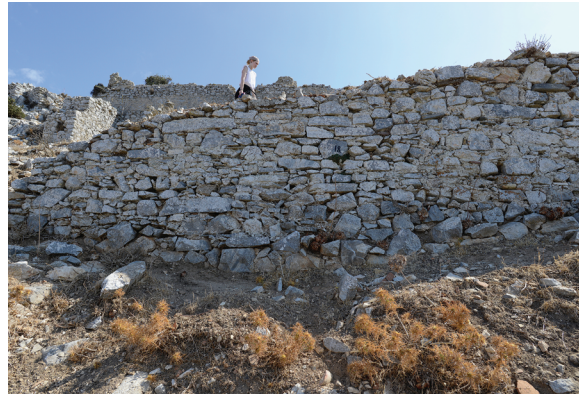
*Figure 18.* Rebuilt and partly collapsed wall on the western side. P on fig. 2.

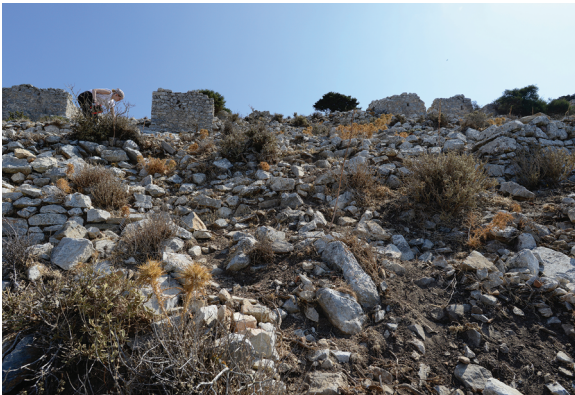
*Figure 19.* Drystone (and partly collapsed) wall on the west side. Q on fig. 2.

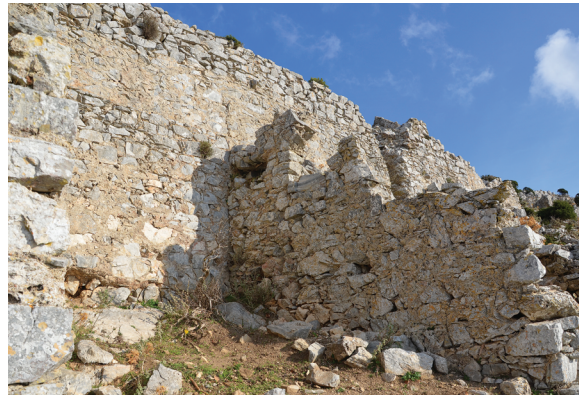
*Figure 20.* Rebuilt building, later converted into a cistern, with buttresses. R on fig. 2.

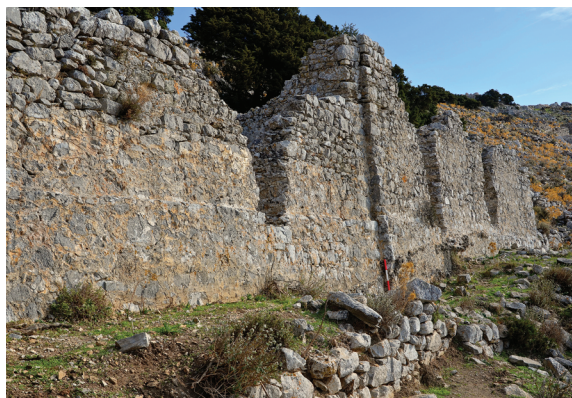
*Figure 21.* Systematic destruction of cistern. S on fig. 2.

One noticeable feature at the Kastro is the systematic destruction of the major cisterns. The massive cisterns on the north-western part of the Kastro had solid walls with standing heights reaching 4.20 m in parts. Besides providing a supply of water, they virtually formed an extra line of effective walls against attackers. The western walls of the large cisterns have been destroyed in parts. It seems that the destruction was carried out in one, systematic operation since the method and position of the damage is identical throughout. One could speculate that the walls were opened to facilitate later reuse of the cisterns, such as for shepherds' shelters, but then one would have expected the openings to extend further down to provide easier access to the interior of the cisterns. The height and the wedge-shaped openings are by no means practical if a function as housing and/or shelter was intended (**fig. 21**). The most likely explanation must be that the destruction was carried out systematically after the Venetian conquest of the Kastro in 1207.<sup>21</sup> Whether this took place immediately after 1207 or later, after Apano Kastro came into function and Chora was again established as an island centre, is impossible to say from the present evidence.<sup>22</sup> Another observation is that the official and most important location within the Kastro is devoid of visible building remains. One possible explanation is that the build-up of soil has completely covered the collapse. However, one could expect more visible stones to be found scattered around this area if it was indeed densely built. On the northern part of the site, building remains, apart from the church complex and a few smaller cisterns, are severely collapsed. One can expect several structures to be buried, since the build-up of soil is significant in this part of the Kastro, but large amount of stones must also have been removed or reused since fewer stones are visible on the surface compared to other parts of the Kastro. The reason for this is uncertain, but could perhaps be considered in connection to the systematic destruction of cisterns and abandonment of the site. In the later phase of the settlement, significant investment in defensive capability took place in this area, and buildings were perhaps destroyed more systematically after the conquest in 1207 to prevent the site functioning as a defensive stronghold again.
