## *The intra-site topography and standing remains of Kastro Apalirou*

David HILL

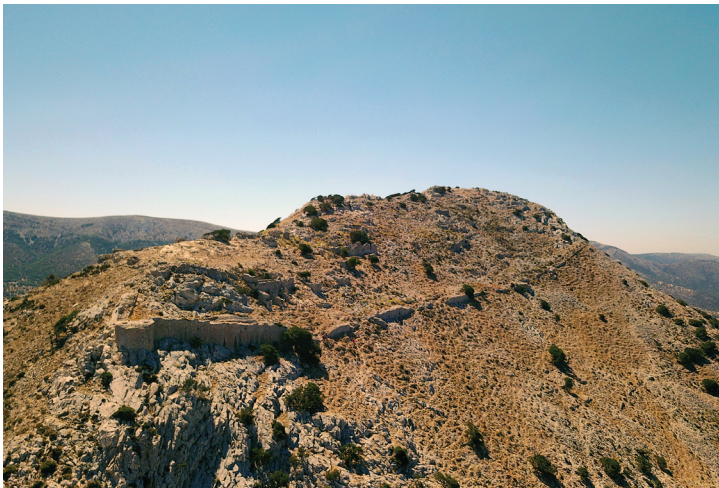
Figure 2. Photo of Kastro Apalirou taken from the north showing the terrain and rocky nature of the site.  
Photo by Hallvard Indgjerd

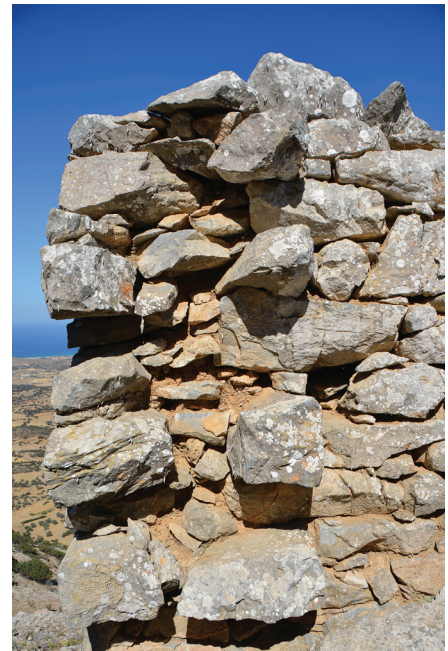
Figure 3. Photo showing clay/earth bonding within a wall and the light use of mortar on its external face.

of a building to seal clay and earth bonding within<sup>1</sup> (**fig. 3**). The majority of domestic buildings were constructed using drystone techniques. When the settlement at Apalirou fell out of use, those buildings where mortar was not used collapsed first, and as such what is visible today as standing architecture are those structures that used bonded masonry, which are largely the high-status houses, cisterns, the defensive structures and the churches.

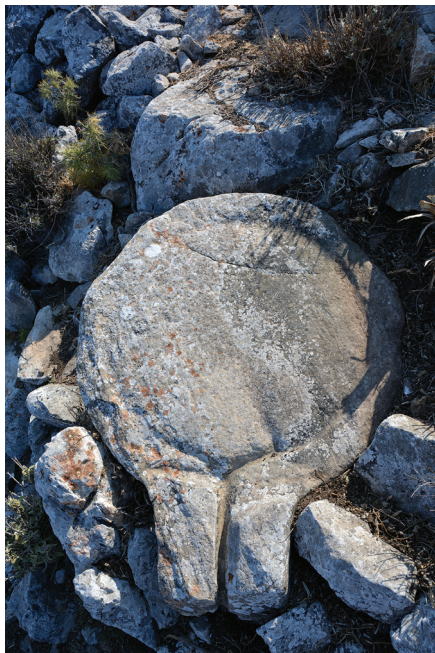
Figure 5. Olive press found in relation to Block House 59.

a fortress) was the identification of cultivation terraces below the walls as being contemporary with the settlement, and the discovery of a stone base of an olive or wine press in connection to one of the houses, which shows that the processing of agricultural produce took place within the walls. (fig. 5) A threshing floor connected to the cultivation terraces below the walls has also been identified.<sup>6</sup>

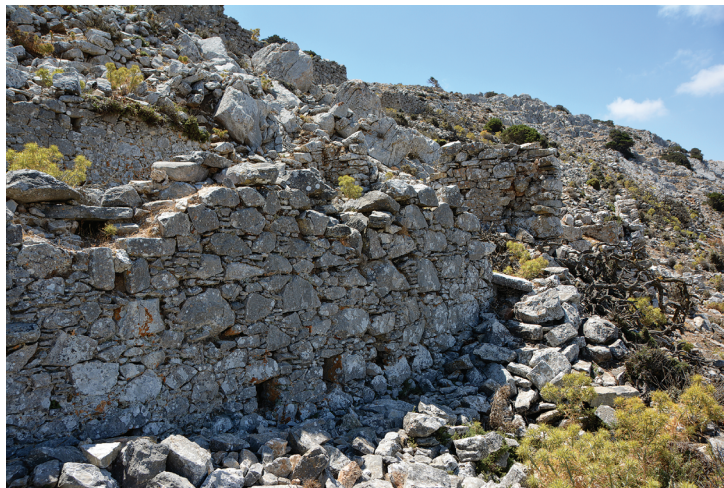
Figure 6. Photo of Terrace House 52 showing slots for the beams over the basement that carried the first floor, and an open area in front of the structure. In the upper left, beam slots for the second floor are visible in the back wall.

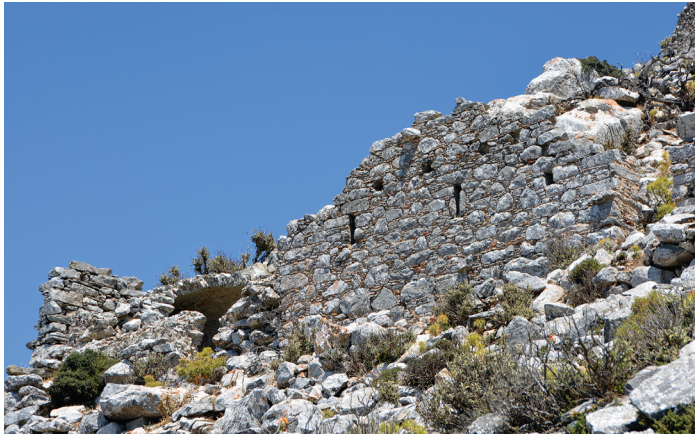
*Figure 7.*

Photo of House 01 showing arrow slits, beam slots above and the vaulted roof of the structure's cistern to the left. To the immediate right of the building a stepped street runs up to the terrace above.

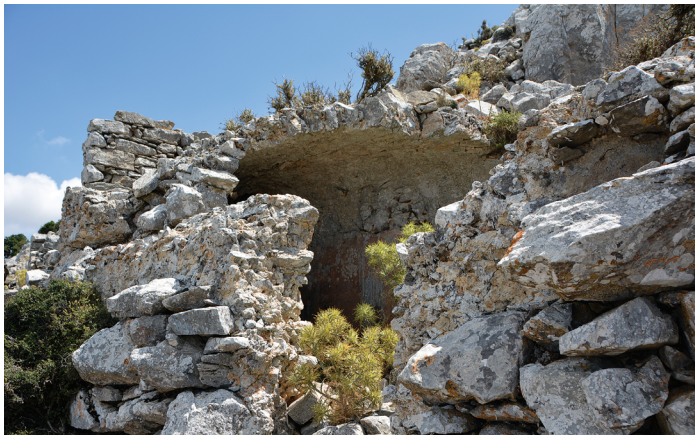
*Figure 8.*

Photo showing the cistern within block house 01.

There are in total forty-six private cisterns, each connected to a particular building and filled by the rainwater runoff from the roof of that building alone (**fig. 8**). These are mostly built into the basements of the buildings to which they belong, though in some cases they are attached to the outside of the building with abutting walls. The way in which runoff water was channelled into the cisterns is unclear as the upper floors and roofs of the buildings are not intact. However, two examples of stone-built gutters and a space in the design of a wall probably to hold a pipe show how this was achieved (**fig. 9**). At the small bath house connected to the Agios Georgios complex, ceramic piping leading into the heated bath is visible (**fig. 10**).<sup>21</sup>

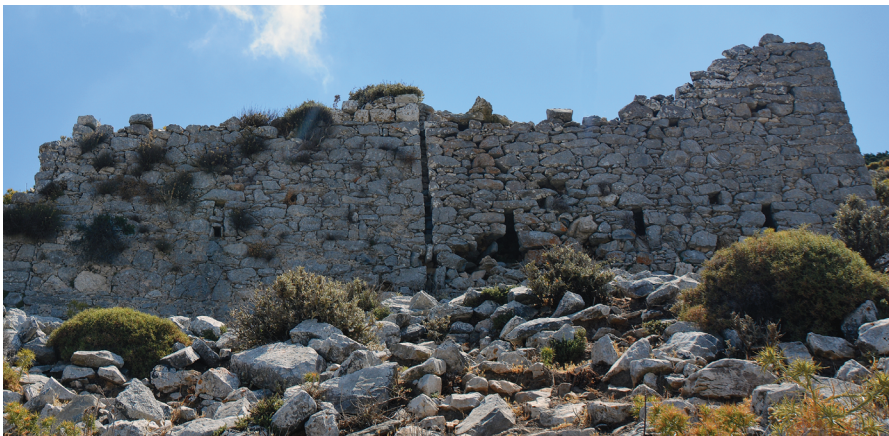
*Figure 9.*

Photo of Block House 49 showing the perpendicular space in the wall that would have held a ceramic pipe leading water down from the roof (marked as E on fig. 4).

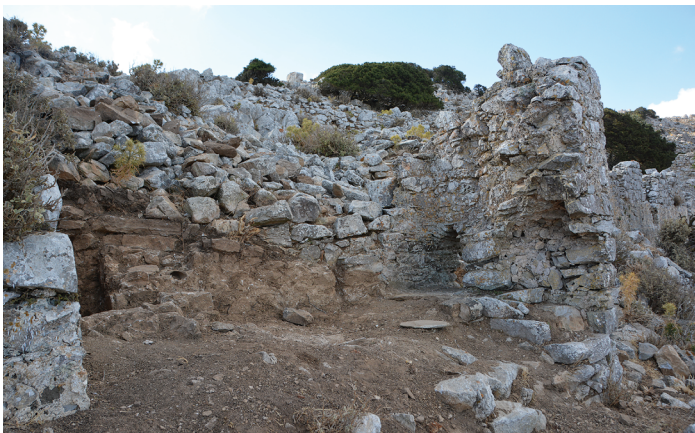
*Figure 10.*

Photo showing the small bath house, note the opening in the wall for the oven (marked as D on Fig. 4).

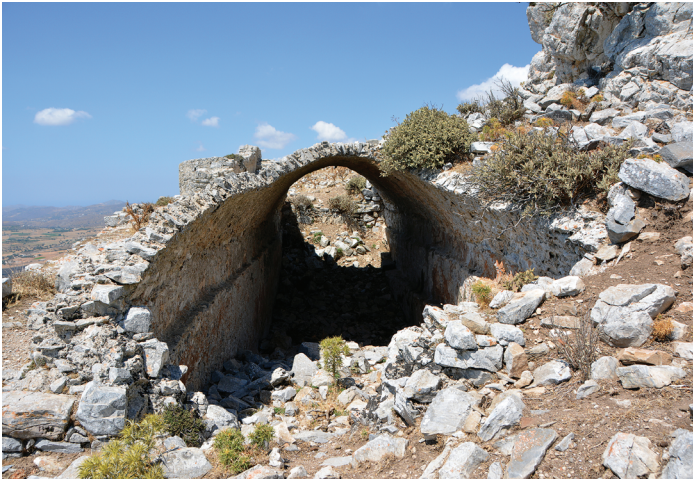
*Figure 11.*  
The large vaulted cistern (marked as A on fig. 4).

There are six large community cisterns at Apalirou situated at the northern end of the town in the vicinity of the Agios Georgios complex and the round tower. The scale of the cisterns clearly shows that there were larger buildings, no longer visible today, immediately up-slope of the cisterns with a roofed area to provide the runoff needed to fill them. The water that was collected from these structures was most likely for strategic storage and non-domestic use. Four of these cisterns were constructed after the round tower was built and the defences were extended, as they would otherwise have lain outside the walls. The large vaulted cistern immediately behind the rampart walk and round tower would not have been constructed before the improvements to the defences (A on **fig. 1**). The large vaulted cistern measures 11.4 m x 2.4 m x 2.3 m which gives a maximum storage capacity of 62.38 cubic metres (**fig. 11**).

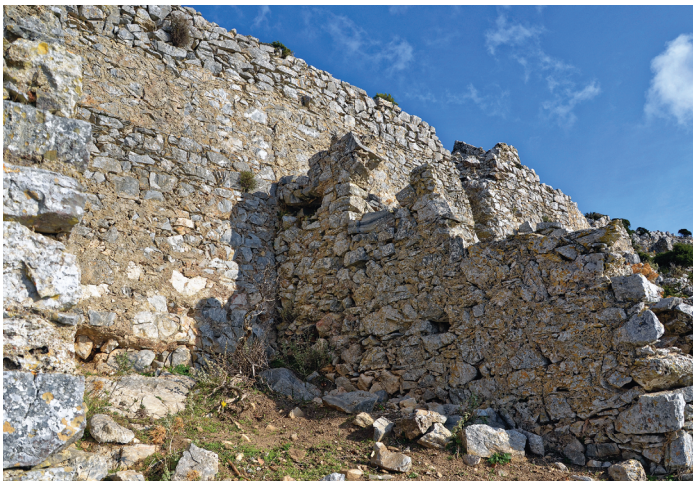
*Figure 12.*  
Cistern to the north of the stepped entrance with supporting buttresses added later when the structure was converted to hold a cistern (marked as B on fig. 4).

In addition, the large cistern to the north of the stepped entrance is a later addition into what was previously a building without a cistern that formed part of the original defensive line (B on **fig. 1**). The construction of the round bastion and the extension of the defences placed this building firmly inside the walls and removed its defensive function. The structure's basement was converted into a large cistern through the strengthening of the inner wall and the addition of a vaulted roof above the basin (**fig. 12**). Three heavy buttresses were also added to the outside of the cistern to give additional support, which would not have been done when this wall made up part of the defences. The internal height of the basin was two meters and the larger compartment measured 11.7 m x 2.7 m, giving a maximum capacity of 72.6 cubic metres, while that of the smaller compartment was 27.6. This cistern could have held up to 100 cubic metres of water. We can interpret these changes as an increased need for strategic water storage at Apalirou perhaps in conjunction with a larger garrison that would have been required to man the tower and ramparts, and here we can argue that preparation for a possible siege situation may have been behind the decision to convert the structure into a cistern.<sup>22</sup> The long system of terrace cisterns to the southwest of Agios Georgios must relate to a roofed area immediately up-slope to the east that is no longer visible; this terrace of cisterns together would have had a capacity of 154 cubic metres, the largest capacity of all the cisterns at Apalirou (**fig. 13**).

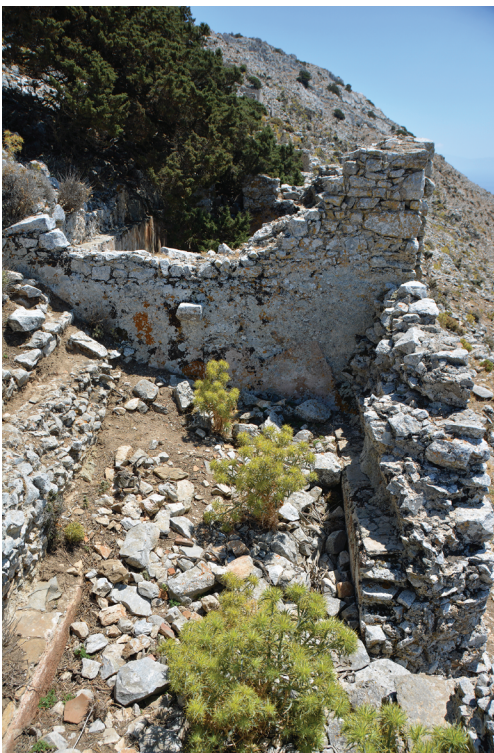
*Figure 13.*  
The long terrace cisterns (marked as C on fig. 4).
