# Factors affecting fracture of zirconia dental crowns

Laboratory studies on retrievals and crown-shaped specimens

Thesis for the degree of Philosophiae Doctor (PhD)  
University of Bergen, Norway  
2022

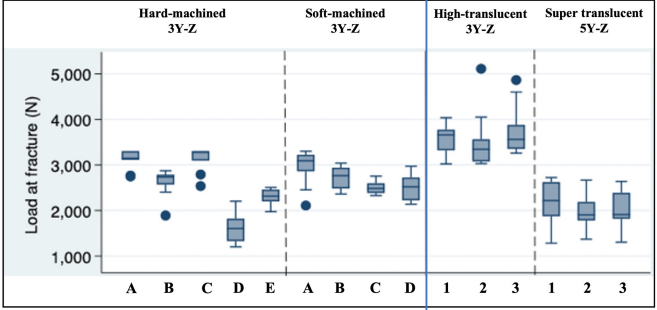
<p>A – chamfer B – slice no collar C – slice with collar D – slice with collar and thin occlusal E – slice with collar and veneer</p>

Study II	Study III
Crown margin quality (median value on a 1-5 Likert scale)	<p>Hard-machined:</p> <ul style="list-style-type: none"> <li>- Chamfer – 2</li> <li>- Slice with collar – 3</li> <li>- Slice no collar – 2</li> </ul> <p>Soft-machined:</p> <ul style="list-style-type: none"> <li>- Chamfer – 2</li> <li>- Slice with collar – 3</li> <li>- Slice no collar – 3</li> </ul>	<p>3Y-Z:</p> <ul style="list-style-type: none"> <li>- Median – 3</li> <li>- Min – 1</li> <li>- Max – 5</li> </ul> <p>5Y-Z:</p> <ul style="list-style-type: none"> <li>- Median – 3</li> <li>- Min – 2</li> <li>- Max – 5</li> </ul>
Load at fracture values (N) given in box-plot

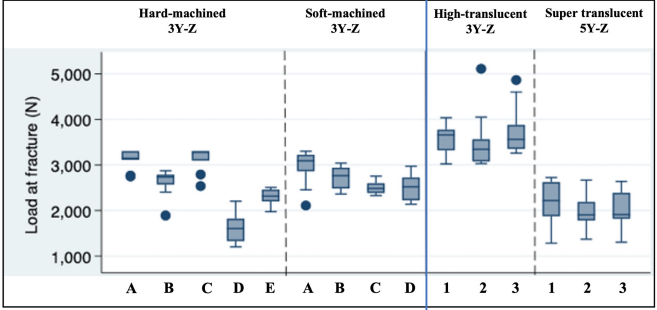
<p>1 – control 2 – dynamic loading 3 – hydro-thermal exposure</p>
Vickers hardness (HV) and c/a ratio	No data available	<p>3Y-Z:</p> <ul style="list-style-type: none"> <li>- HV: mean – 1321</li> <li>- c/a ratio: 1.5</li> </ul> <p>5Y-Z:</p> <ul style="list-style-type: none"> <li>- HV: mean – 1357</li> <li>- c/a ratio: 2.5</li> </ul>

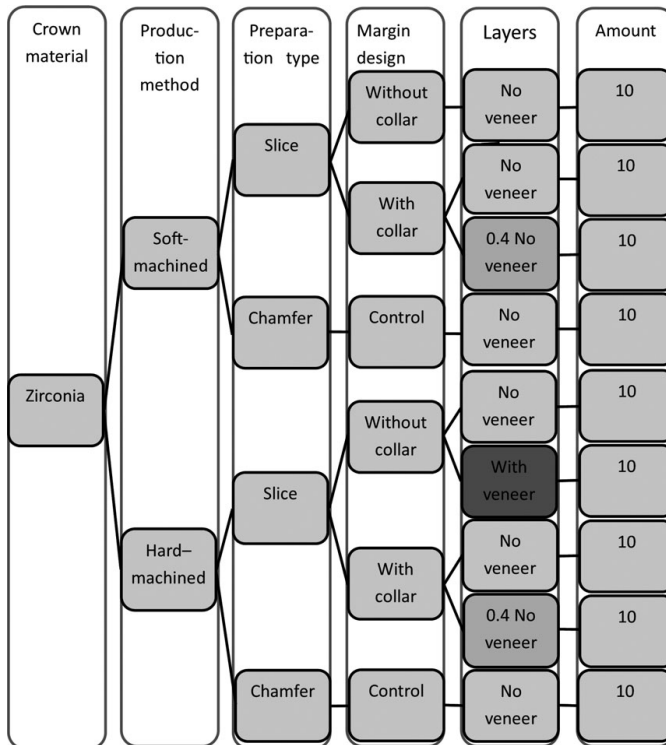
Fig. 4. Flow chart of the crown production. The veneered crowns are indicated with darker shadow.

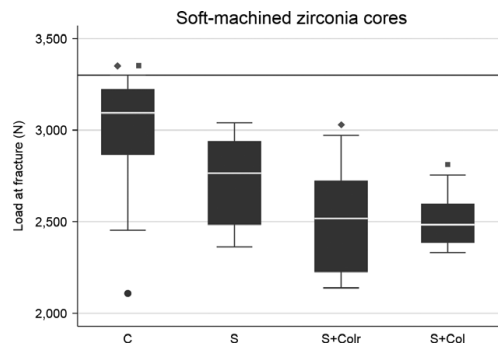
Fig. 6. Box plot of the four soft-machined groups with different margin designs. Further load was stopped at 3,300 N (horizontal reference line at y-axis) as a result of equipment limitation. The line within boxes represents the median, and the bottom and top of boxes represent the first and third quartiles, respectively. The maximum and minimum whiskers represent 1.5 interquartile ranges. Statistically significant differences between groups are marked with corresponding squares or diamonds. C, chamfer; S, slice; S + Colr, slice with cervical collar and reduced occlusal thickness; S + Col, slice with cervical collar.
