Ceramics as an indicator of building chronology at Kastro Apalirou: Preliminary observations.

Hallvard R. INDGJERD

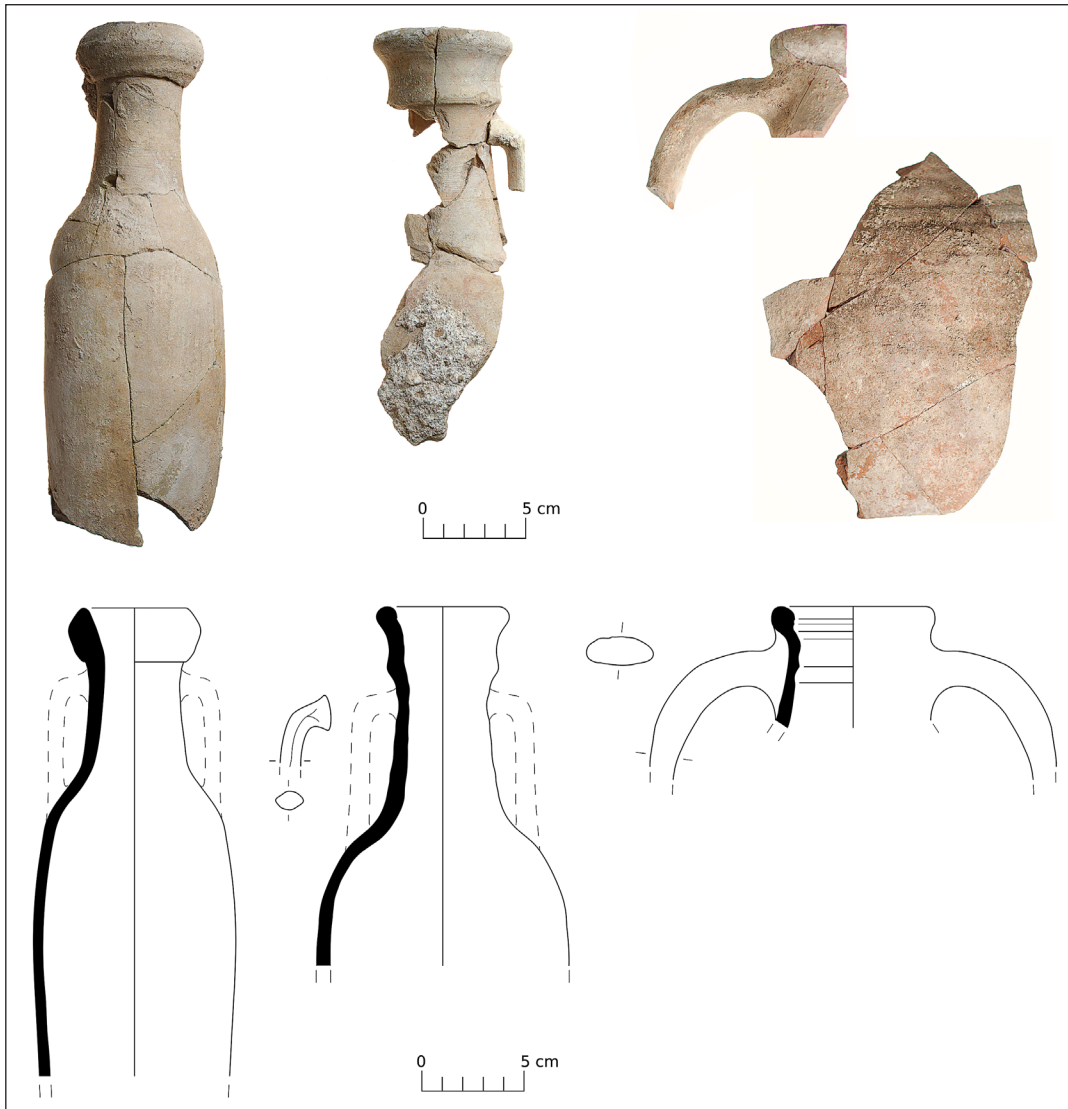
Figure 1. Amphorae with mortar from the collapse in the 'Small Church'. 2015-039 (left), 2015-040 (centre), 2015-041 (right).

beehives are also common. The two well-preserved vessels (2015-039 and 2015-040) (**fig. 1**), have been identified as Spatheion 3 amphorae (Keay 26). These ‘miniature amphorae’, less than 50 cm in height and containing up to 3 litres, have been dated to the mid-6th to end of the 7th century, with the main production centre in Tunisia.⁵ Both were found close to the floor level in the south-eastern part of the excavated area, and have mortar attached to their exterior surface. While it is possible that the bases and lower parts of the vessels are in the un-excavated part of the church, it seems more likely that only the upper parts were used in the construction as there are no non-joining sherds belonging to them in the rest of the trench. Thirty-eight sherds (2015-041) (**fig. 1**) of a Late Roman Amphora 1 (LRA1), constituting the rim and upper handle, a lower handle attachment and several larger pieces of the body, also had mortar attached and must have been used as building material. The amphora has an approximate date in the 5th to mid-7th century.

In addition to the use of sherds and fragments as wall material, larger semi-complete vessels could also be incorporated into the construction as lighteners or, simply, shelves, as is seen e.g. in the Middle Byzantine church of Agios Georgios Dorgana in Kastro Koskinas on Ikaria (**fig. 2**).⁶ It is possible that some of the larger parts of beehives and amphorae found in the excavation served this purpose (e.g. 2015-041).

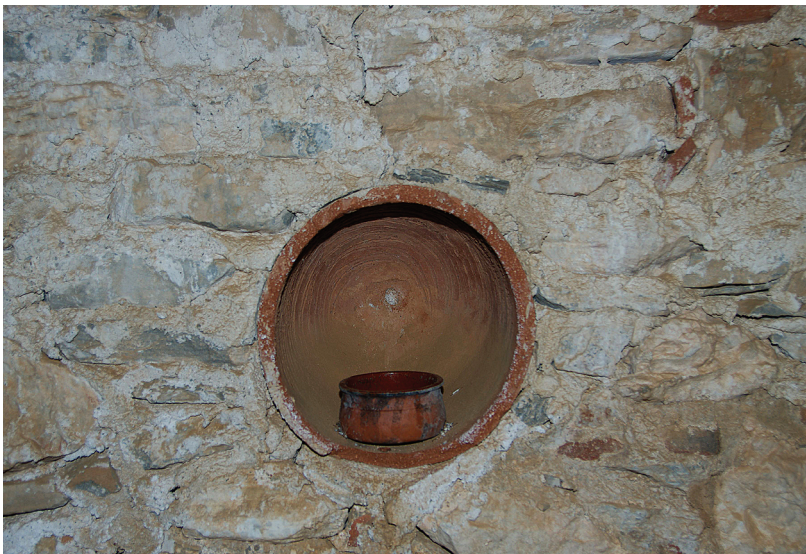
Figure 2. Beehive as shelf in Agios Georgios Drogana, Ikaria.

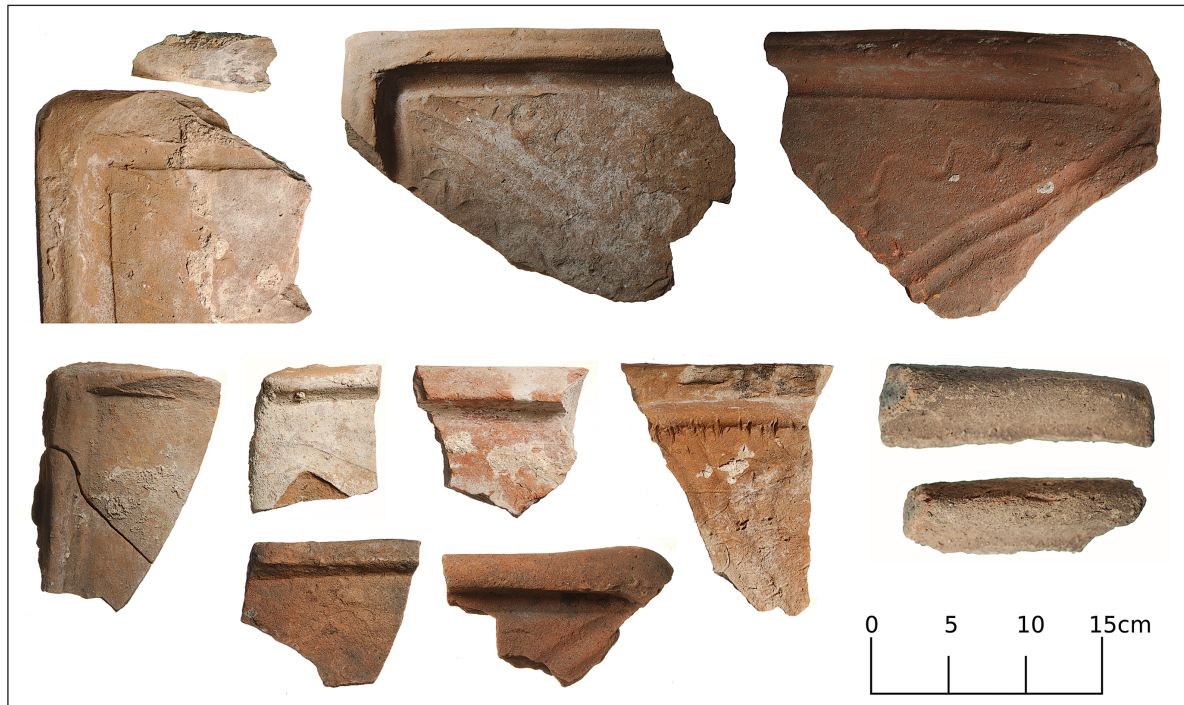
Figure 3. A selection of different tegula types from the collapse of the ‘Small Church’.

The collected material includes 342 fragments (a third of the total count) of CBM in the form of tile (tegulae and imbrices) and brick. The most striking feature of the CBM is the large variation in shape and fabric (**fig. 3**). Differently shaped roof-tiles do not work well together on a single roof cover, as the tegulae and imbrices are produced to fit together. In combination with the frequent occurrence of mortar on break surfaces, and the lack of complete tiles or bricks even when joining has been attempted, it must be concluded that the CBM is in secondary use in the church, in much the same way as the broken pottery, and that the presence of roof-tiles cannot indicate a tiled roof. The large variation in the CBM fabrics could indicate that Naxos, as other areas of the Roman and Early Byzantine empire, imported a major part of the tiles used.⁷ A further petrographic analysis of the tile types could provide interesting details on the CBM trade reaching the island, even if it might not be directly linked to the construction of Kastro Apalirou.

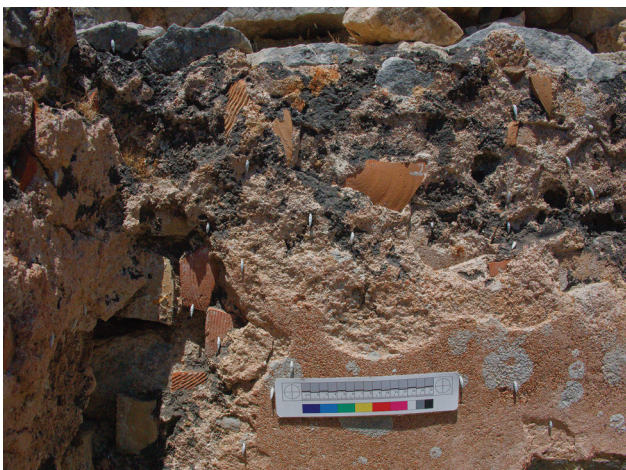
Figure 7.
Sherd layer, including LRA2 sherds, visible in breaks of the lining in cistern 7.

Only body sherds were used to build up the pottery layer of the lining, so the amount of visible diagnostic features is limited. The majority are of medium thickness (5-10 mm) and had come from medium or large closed vessels (probably amphorae); however, many display spiral grooving, bands of fine combing, and slipped external surfaces. The spiral grooving is typical of the upper body of the Late Roman Amphora 2 (LRA2), generally dated 5th-7th century, and of later Byzantine globular amphorae of the 7th and 8th century.²³ Although the technique is also found on other closed Late Roman and Early Byzantine vessels,²⁴ several of the sherds, especially in cistern 7, can also macroscopically be connected with the LRA2 type (**fig. 7**). These amphorae are not uncommon in the Apalirou survey material, but are far more frequent on Late Roman sites surveyed elsewhere on the island.²⁵ The type of straight or wavy bands of fine combing seen on many of the sherds became common towards the end of the Late Roman period,²⁶ but has remained in use on larger closed vessels up until modern times,²⁷ and cannot in itself contribute much to the dating of the structures. Combined, however, with the high proportion of LRA2 sherds, the prevalence of fine, high fired fabrics, and the lack of identifiable later vessels, it points towards a possible early (6th-7th or 8th century) date for the use of this lining technique, which may mean that the affected cisterns would have been built by this time.
