The churches of Kastro Apalirou

Knut ØDEGÅRD

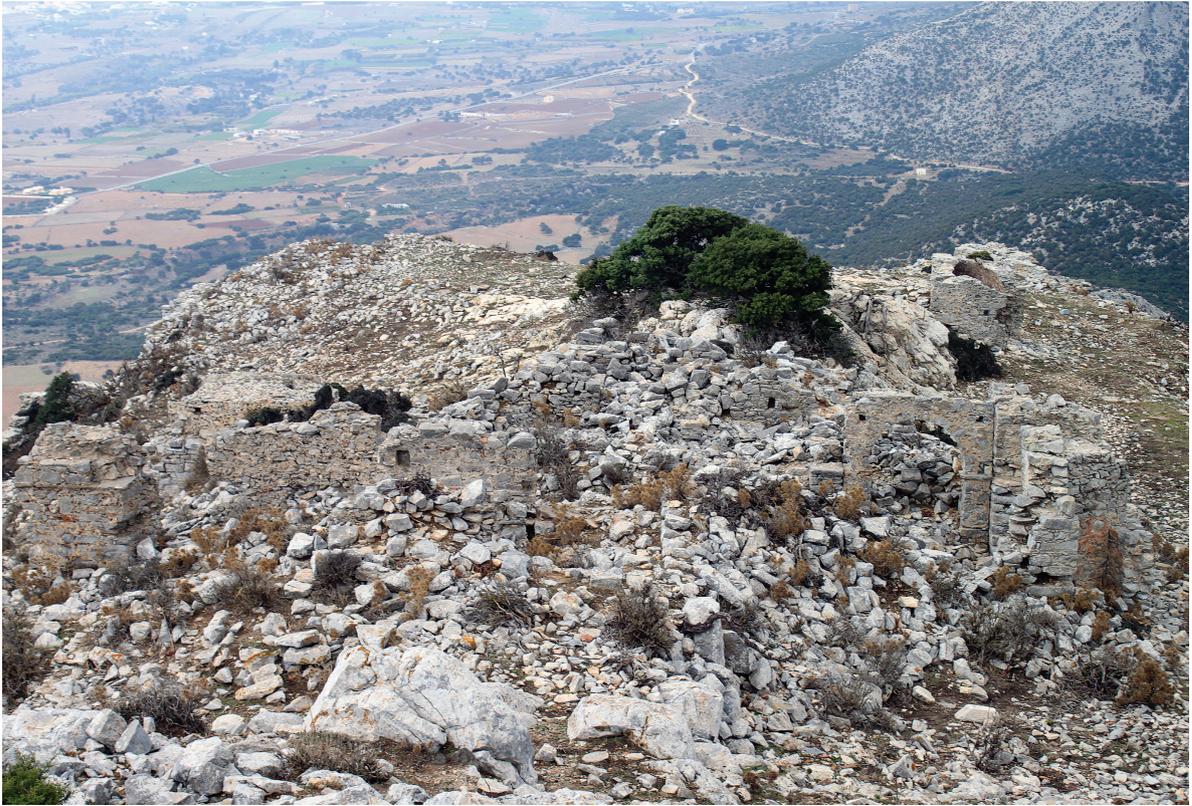
Figure 1. Agios Georgios complex seen from the south.

The largest and most visible of the churches in and around Kastro Apalirou is undoubtedly the large complex known traditionally under the name of Agios Georgios (**fig. 1**). There are no historical sources for this name, but popular tradition holds that the patron saint was St. George; as one of the most important military saints, such a dedication is certainly appropriate for the main church of fortified town. As one of the best preserved structures in Kastro Apalirou, the church of Agios Georgios was known, and partly studied, before the Norwegian project. It is mentioned briefly by Mastoropoulos² and it has also been discussed more recently in more detail by Aslanidis.³

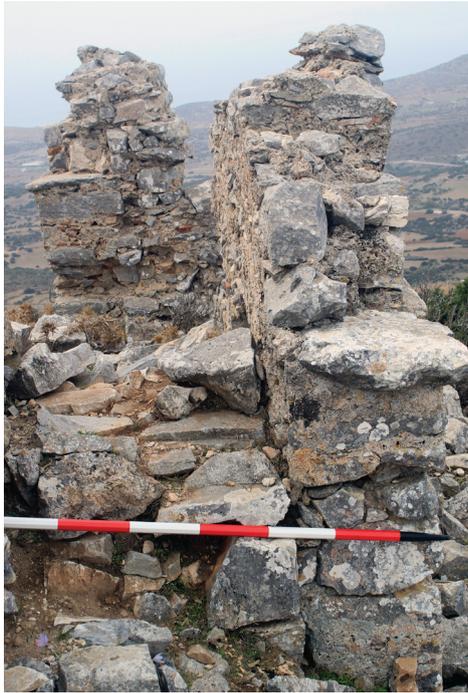
Figure 3. Northern wall of Building E (left) and southern wall of Building A (right).

collapsed (**fig. 3**). We can only assume that at a later stage they were connected by a stairway in the western part of the complex. Building F bears clear signs of being rebuilt by a strengthening of the inner walls, probably connected to the insertion of an apse in the east and the construction of a barrel vault and a dome over the central part of the aisle. The lower part of the vault is visible on both the southern and northern walls of the building and springs from a horizontal layer of regular pieces of slate.

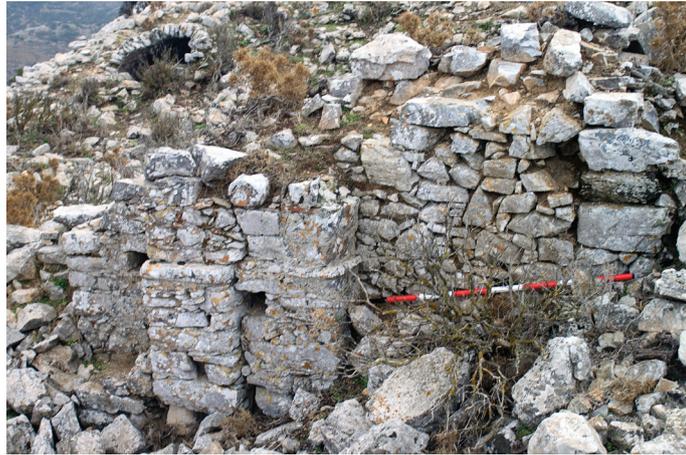
Figure 4. Piers inserted on the southern wall of Building A, probably connected to rebuilding the roof.

Also the main part of the complex, Building A-B, the double-aisled central church, shows signs of reconstruction, modification or repair. This is evident in the insertion of piers along both the southern and northern walls of the main aisle. These piers are in two or possibly three different phases and are probably connected to different roof constructions or repairs (**fig. 4**). It is possible that the interior was once covered with a barrel vault, which at a later stage was reconstructed with a dome over the central part of the aisle.⁹ In one of these roof reconstructions, arches were inserted between the main aisle and the northern narrow aisle (**fig. 5**). These arches were constructed with far more use of broken tiles in the masonry than in the rest of the building. The northern narrow aisle (2.60 m wide) also shows signs of repair or reconstruction through the addition of six corresponding piers, presumably inserted to strengthen a new barrel-vaulted roof.

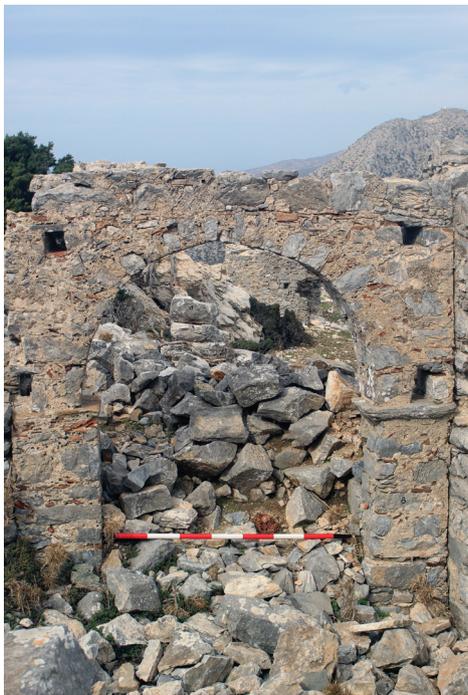
Figure 5. Arch inserted into the main aisle of Building A.

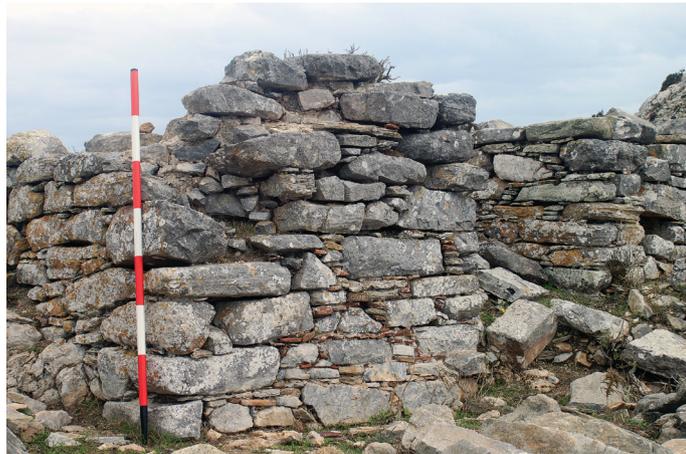
Figure 6. Northwestern corner of Agios Georgios complex (buildings D and C).

Two chapels, C and D were added at a certain stage to the main complex, with communication through a doorway in the northwest wall of the double-aisled church. As noted above, the building technique is different, with consistent use of larger and more regularly hewn blocks in corners and gateways and mainly in alternate directions, as headers and stretchers (**fig. 6**). The two chapels are joined to the main complex at an oblique angle, presumably because a rocky outcrop to the north and the general topography made a regular plan difficult. Both chapels had apses, the northern one clearly inserted at a later stage. There are no internal piers in the two chapels and they were presumably roofed by barrel vaults.

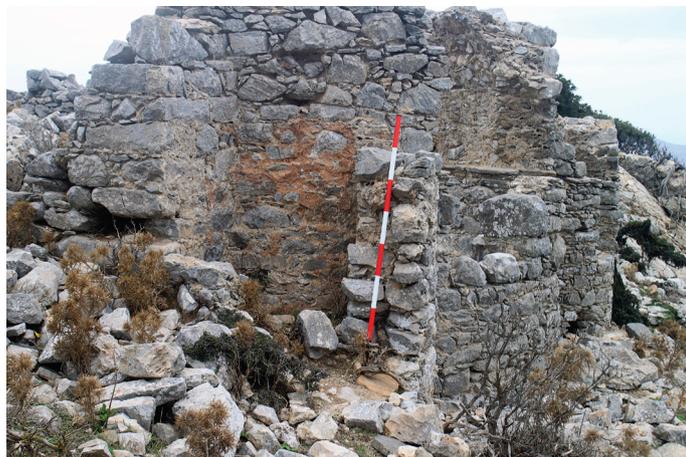
Figure 7. Eastern facade of Agios Georgios seen from the south, with the small cistern in the foreground.

The eastern exterior face of the complex is reasonably well preserved, with the imposing central apse with its two large windows. Unfortunately they have both collapsed, but their lower width seems to be around 0.80 m. The adjacent apse of the smaller, north aisle was clearly constructed at the same time, since some larger stones in the masonry project into the next apse, but the single window in the north apse is smaller, with an exterior lower width of about 0.40 m. Seen from the east, the exterior face of the church actually appears as a three-aisled basilica, since a small, half-circular structure has been inserted on the southeast corner (**fig. 7**). This is undoubtedly a cistern due to the presence of reddish hydraulic mortar on the inside, and must have been fed from the roof of the double-aisled church. The shape of the cistern is peculiar, and how water flowed out of the cistern and to where is unknown. The visual appearance of the eastern end of the church may also have been of importance and may be the reason behind this peculiar addition to the building.

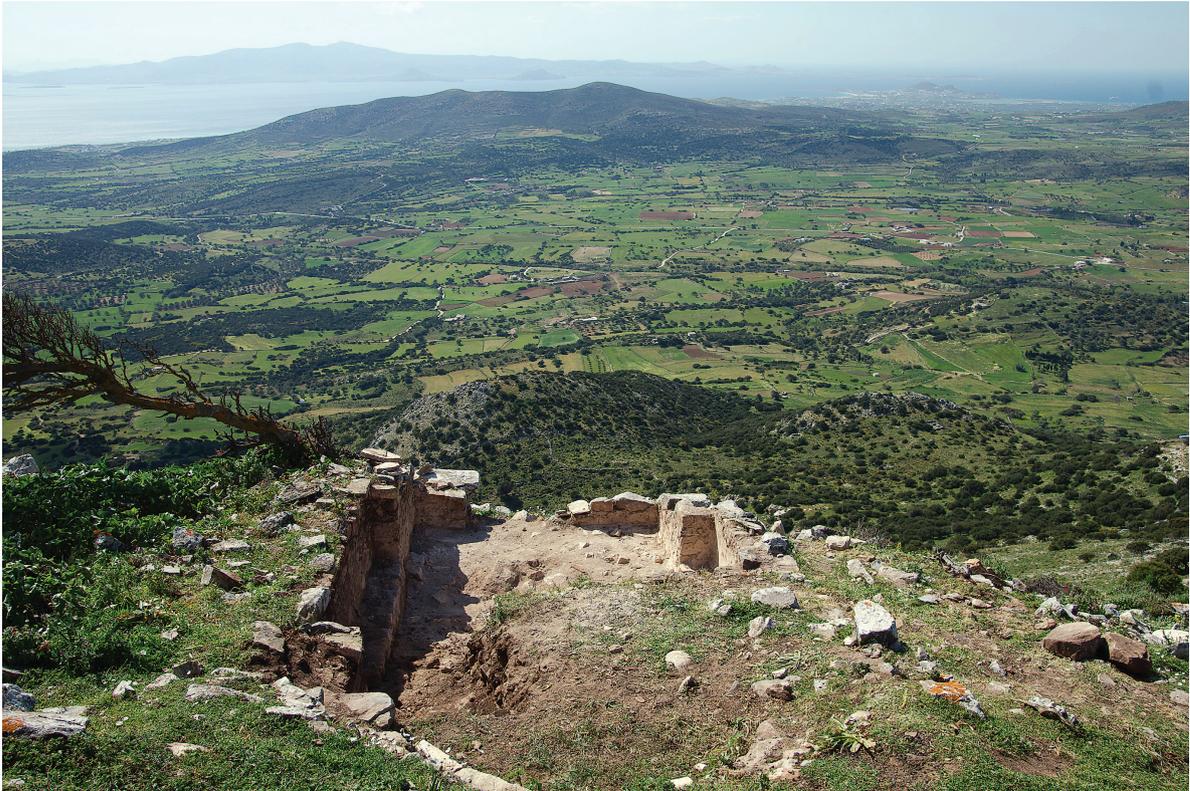
Figure 8. The small double-aisled church and its location near the southern peak of Kastro Apalirou after excavation in 2016 (photo: H. Indgjerd).

During the first seasons of archaeological documentation of the visible structures of Kastro Apalirou between 2010 and 2014, a small double-aisled church was discovered near the south summit of the urban area. The structure was not initially identified as a church, since the building was completely filled by debris and soil, but during a particularly dry autumn in 2013, two apses were clearly visible as soil marks. On removal of vegetation and closer inspection, it was possible to suggest a plan for the building, with two aisles ending in apses of about the same size and a probable narthex at the western entrance (**fig. 8 and fig. 9c**).

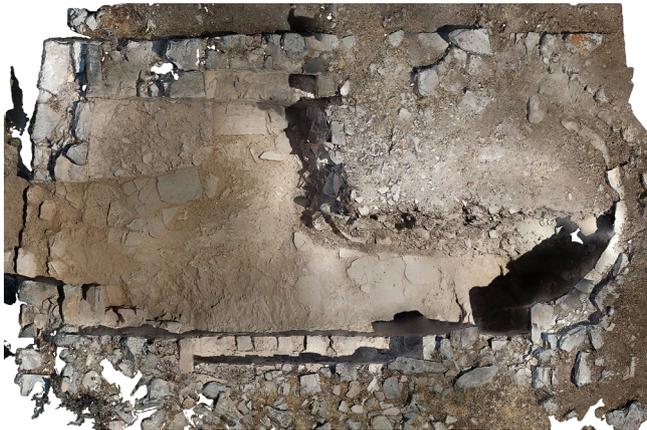
Figure 9a.
Photogrammetric plan of the excavated northern section of the small double-aisled church after excavation in 2016 (by H. Indgjerd).

The floor level consisted of clay, flat stones and bedrock, and aimed simply to create a fairly level surface. This level was reached in about 2/3 of the building, the rest remains unexcavated. There are two corresponding recesses in the wall on the south and north side. Mortared benches were inserted in these recesses, but no further refinements of the inner building have been encountered. The southern part of the apse was exposed and a fine, but thin mortared surface appeared, but there are no signs that it had ever been decorated or painted.

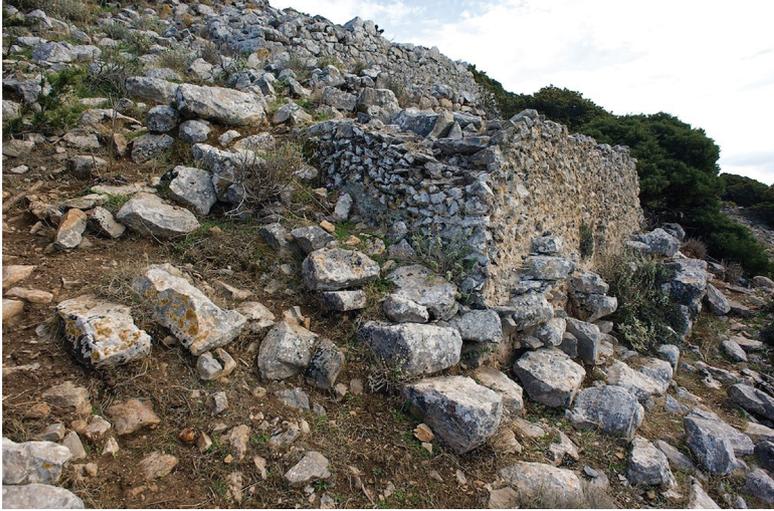
Figure 11.
Terrace supporting house with cistern, below, and narthex of church, above.

The structure situated slightly lower to the west is composed of a solidly built rectangular building with an attached rectangular cistern to the west. The plan has a lot in common with the houses of Kastro Apalirou. Both this possible house and the church were evidently made in conjunction with the large terraces leading northwards, but we do not yet understand the relationship between these different structures. The building technique is, however, similar in all structures. The walls are generally very solidly constructed, with large and well-hewn blocks and mortar mainly on the interior of the walls. The masonry can be compared with type 3 described above in connection with Agios Georgios (**fig. 6**), used for the later phases of the church complex there.

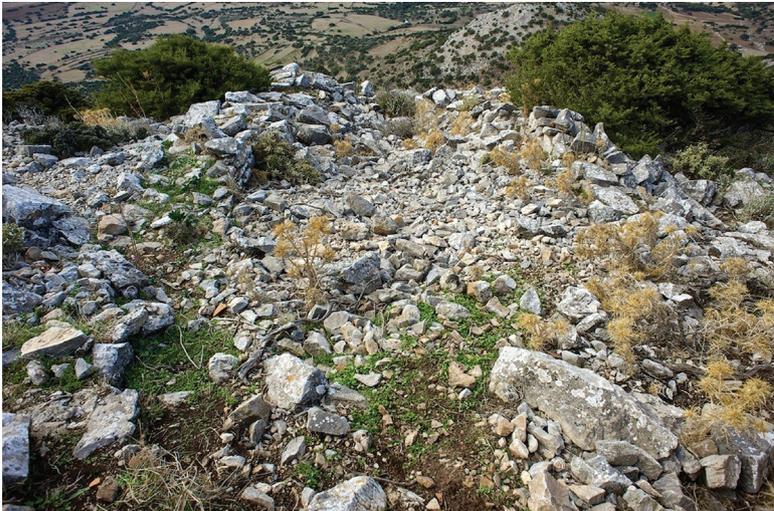
Figure 12.
Main aisle of extramural church.

The church itself is a wide single-aisled structure, 9.50 x 3.50 m, with two massive piers on the interior (**fig. 11**). As the eastern part of the church is filled with a greater quantity of debris than the western, we cannot yet know whether there were two more corresponding piers further east. If this was the case, one might posit a central dome, such as in the church of Agios Ioannis Adissarou around 2 km further west. This is perhaps likely, since the two visible piers would otherwise be difficult to understand structurally. There are, in fact, several features in common with Agios Ioannis Adissarou, such as the ratio width to length, although this newly discovered church is slightly larger.¹⁸ Only few traces of the apse remain above ground, the exposed sections present a slight curve upwards and thus we may assume that the floor level must be considerably lower down in this eastern part of the building. The apse is without clear indications of mortar or stucco. There seem to be remains of an opening towards the north adjacent to the apse. This opening gave access to another structure which can only be traced in outline, but which definitely had a very small apse on its east end, towards the church. Furthermore, a small square cistern can be discerned on the northeast corner of this structure. There also seems to be a square room to the west, aligned with the church. Both rooms to the north of the church are very poorly preserved on the surface; we have no certain indication of the thickness of the walls nor how the rooms communicated. We do not even know where the main entrance to these rooms was.

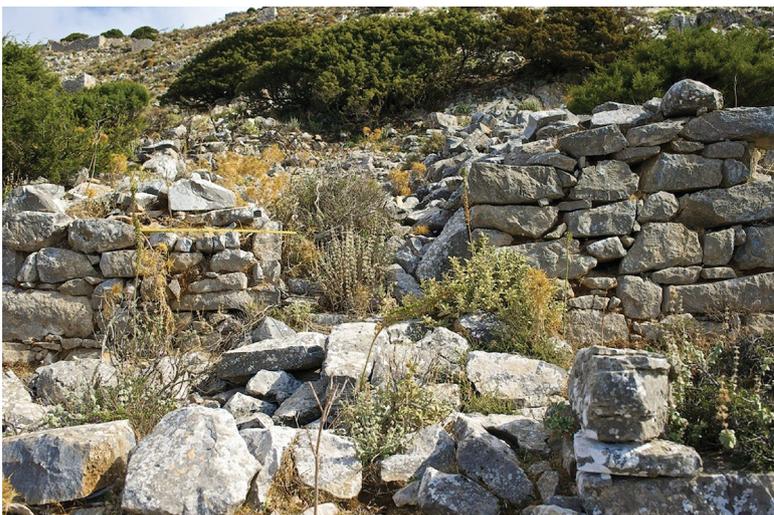
Figure 13.
Entrance to the main aisle of the extramural church, with remains of the narthex in the foreground.

The combination of what could be a dwelling and the church with its attached buildings could perhaps point to a monastic complex, but this remains uncertain until further documentation and studies are undertaken. The very wide narthex (9.00 meters) covers not only the entrance to the church (**fig. 12**), but also conceals from below the adjacent rooms to the north of the church. This suggests that there was a unified design and that the plan deliberately exploited the imposing terrace and lofty location of the church.
