## Reconnaissance report and preliminary ground motion simulation of the 12 May 2008 Wenchuan earthquake

Louise Wedderkopp Bjerrum · Kuvvet Atakan ·  
Mathilde Böttger Sørensen

**Keywords** Damage distribution · Field reconnaissance · Ground motion simulation · Wenchuan earthquake

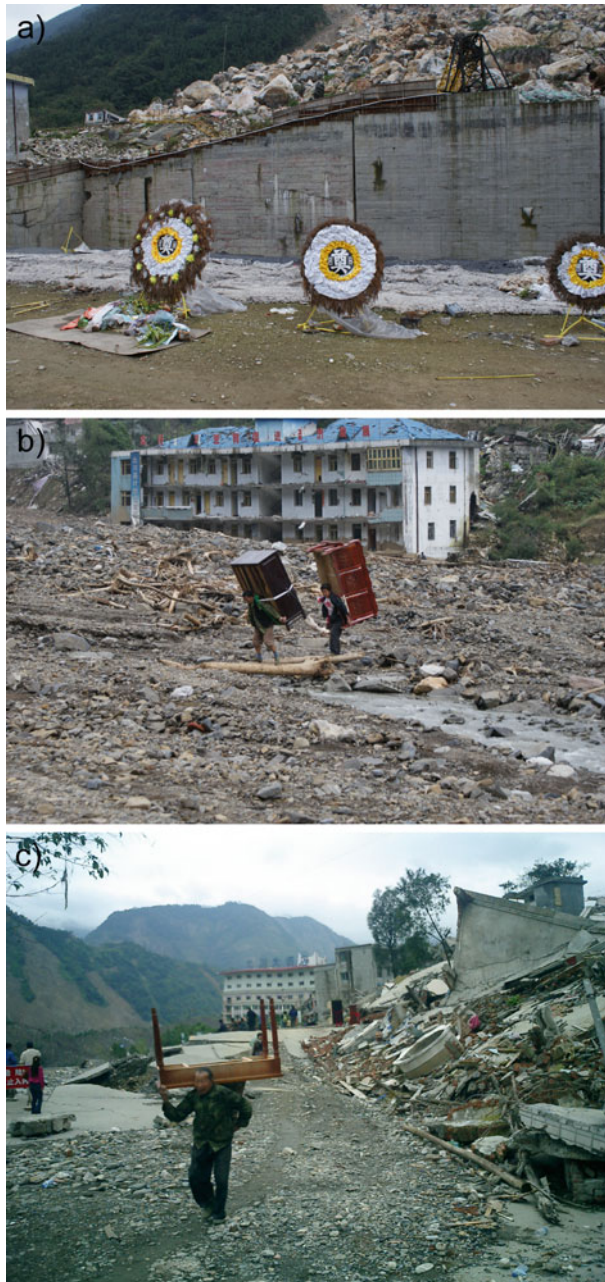
An enormous number of people were killed or injured in Beichuan as a result of the earthquake and the landslides that followed. A mass grave was established in the central part of the city where a new building was under construction at the time of the earthquake (Fig. 21a). During our visit in Beichuan, we observed several people entering damaged and tilted houses to collect their belongings (e.g. the building shown in Fig. 10f), and the survivors were still carrying belongings from the valley and over the mountain side to the temporary shelter towns (Fig. 21b,c).

**Fig. 21** a Mass grave and memorial site in the center of Beichuan. b–c Survivors gathering belongings in Beichuan and carrying them out of the city valley to the newly constructed temporary shelter town on the mountain side south of the city

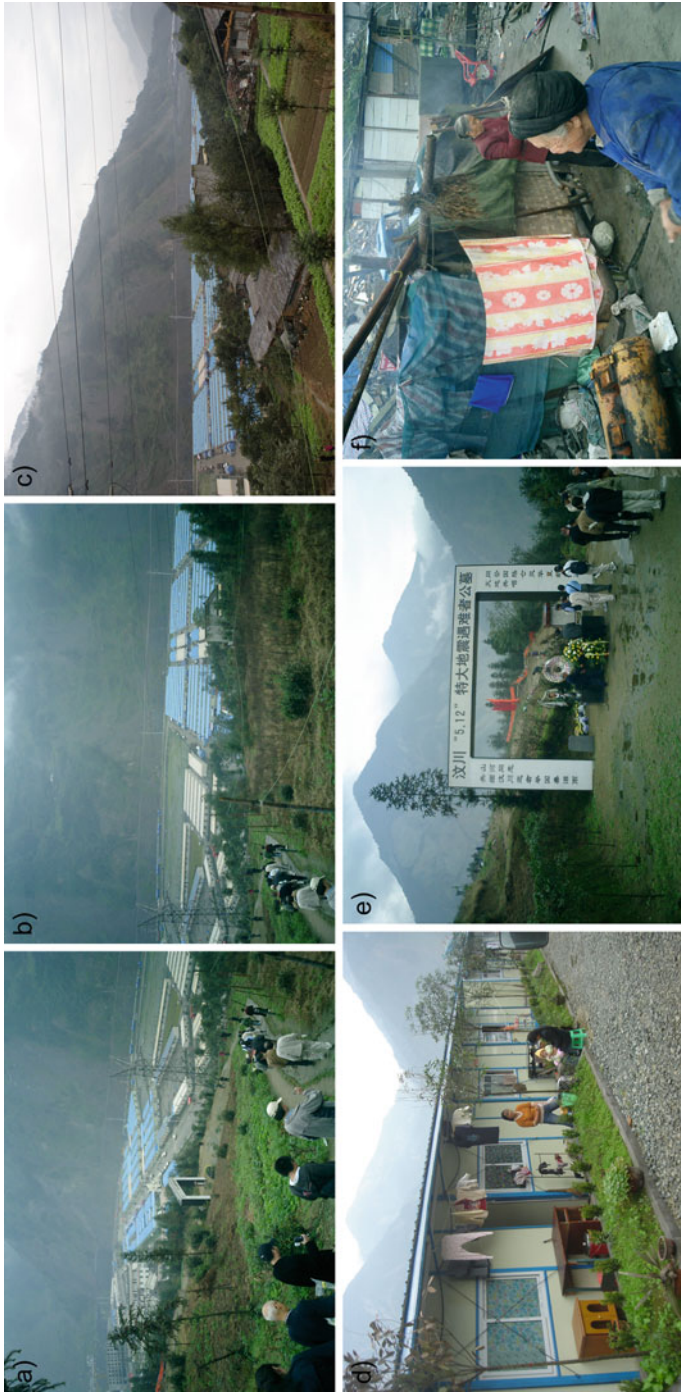
In Yingxiu, in the epicentral area, two large temporary shelter towns had been constructed; one covering a large part of the valley south of the city (Fig. 22a–d), the other on top of a nearby hill. New schools and activities for the children were established, and large gardens were available for growing vegetables for the surviving population. The memorial site for the earthquake was located on the hill side, between the upper and lower shelter town (Fig. 22e). In addition to the large number of shelters provided by the authorities, there were several self-constructed shelters/tents of various qualities. In Yingxiu, the shelter shown in Fig. 22f, was situated only few meters from the fault scarp shown in Fig. 3a.

**Fig. 22** a–d Temporary shelter towns near Yingxiu, extending through the narrow valley south of the city. Landslide scarps are visible in the background. e Memorial site for the earthquake in Yingxiu. f Self-constructed shelter near the fault scarp in Yingxiu

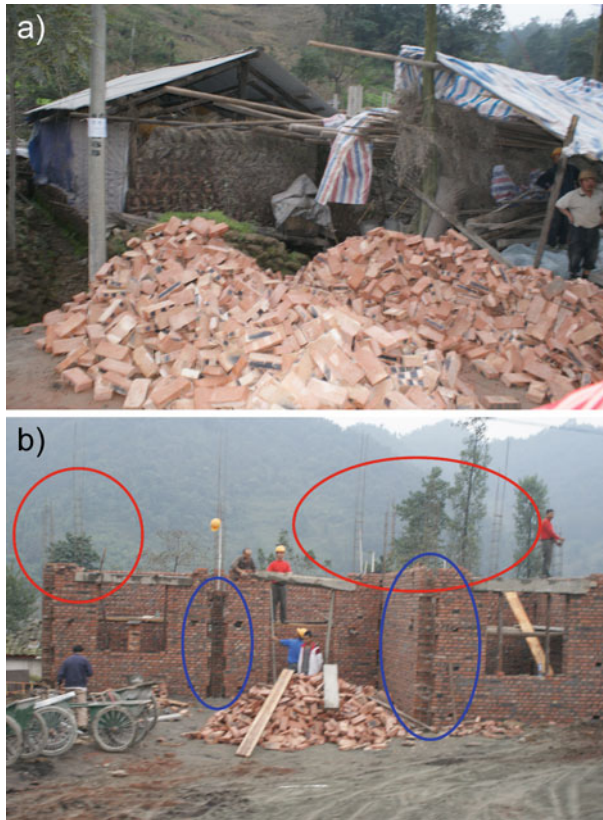
The reconstruction of the earthquake affected area was still ongoing at the time of our visit. The authorities have provided building material for construction of new houses to the survivors, an example of this is given in Fig. 23a. Reconstruction was usually done by the

**Fig. 23** Reconstruction work near Bailu. **a** Piles of bricks visible along the road. **b** Construction of simple reinforced concrete building with brick infill. Notice the concrete columns in the corners (*marked with blue and red circles*) are until now only visible due to the simple metal structure, while the concrete columns have not yet been made

local population as in Fig. 23b, and most of the structures were either of brick-reinforced concrete type or brick-wood type. The vulnerability of these structures in future earthquakes is expected to be high.
